# Access Compliance Report

## Public Rights-of-Way

### (Curb Ramps)

Intersection ID: 53284	Main Street: BENFIELD_RD	Cross Street: ROBERT_HELMS_RD	Location: S
ADA ID: 05E308B7DDA8	Ramp Type: Perp	Initial Pass/Fail: Fail	Overall Compliance: No
Severity Score: 13.75			
Codes/Mitigation Info/Possible Solution		Field Measurements/Component Compliance

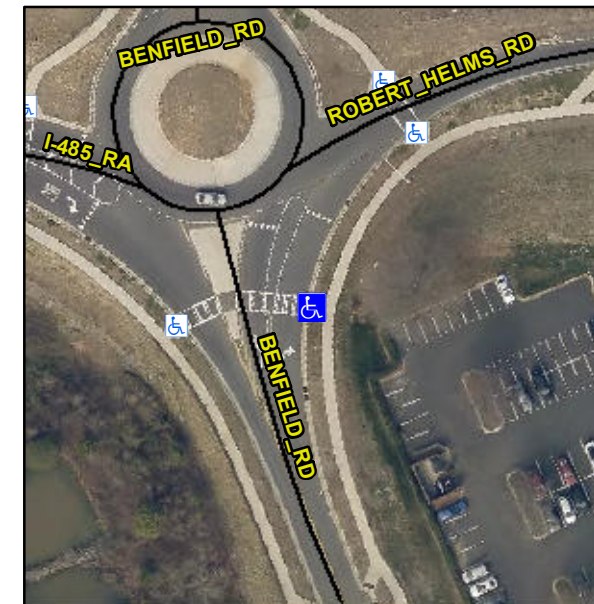
Compliance	Description	Data	Compliance	Description	Data
N/A	Ramp Length (in)	87.0	No	Ramp Slope (%)	11.6
Yes	Ramp Width (in)	48.0	No	Ramp XSlope (%)	4.5
N/A	Flare Type LT	N/A	N/A	Flare Type RT	N/A
N/A	Flare Slope LT (%)	N/A	N/A	Flare Slope RT (%)	N/A
N/A	Flare Traversable LT?	N/A	N/A	Flare Traversable RT?	N/A
N/A	Landing Length (in)	N/A	N/A	DWS Provided?	N/A
N/A	Landing Width (in)	N/A	N/A	DWS Contrast?	N/A
N/A	Landing Slope (%)	N/A	N/A	DWS Length (in)	N/A
N/A	Landing X Slope (%)	N/A	N/A	DWS Full Width?	N/A
N/A	Landing Curb? (Y/N)	N/A	N/A	DWS Offset (in)	N/A
N/A	Shared Landing?	N/A			
N/A	Gutter Ponding?	N/A	N/A	Gutter Slope (%)	N/A
N/A	Gutter Lip Ht (in)	N/A	N/A	Gutter X Slope (%)	N/A
N/A	Painted X Walk1?	Yes	N/A	Painted X Walk2?	N/A
	X Walk 1 Direction	To W		X Walk 2 Direction	N/A
N/A	X Walk 1 Width (in)	104.5	N/A	X Walk 2 Width (in)	N/A
	X Walk 1 Slope (%)	2.2		X Walk 2 Slope (%)	N/A
	X Walk 1 X Slope (%)	4.4		X Walk 2 X Slope (%)	N/A

N/A	Ramp inside XWalk1?	Yes	N/A	Ramp inside XWalk2?	N/A
	Road Slope (%)	N/A	N/A	Clear Space?	N/A
	Road X Slope (%)	N/A	N/A	Clear Space to XWalk (in)	N/A
N/A	Any Obstructions?	N/A	N/A	Storm Grate/Utility Hazard?	N/A
	Obstruction Type			Storm Grate/Utility Type	
		N/A			N/A
		Yes		Surface Condition? (G/P)	Good

**Remove & Replace Entire Ramp.**

**R304.2.2, R304.5.3**

Total Cost: \$ 1850.00
