# Access Compliance Report

## Public Rights-of-Way

### (Curb Ramps)

| Intersection ID: 21948 | Main Street: SARDIS_RD | Cross Street: SARDIS_RD_NORTH | Location: SW |

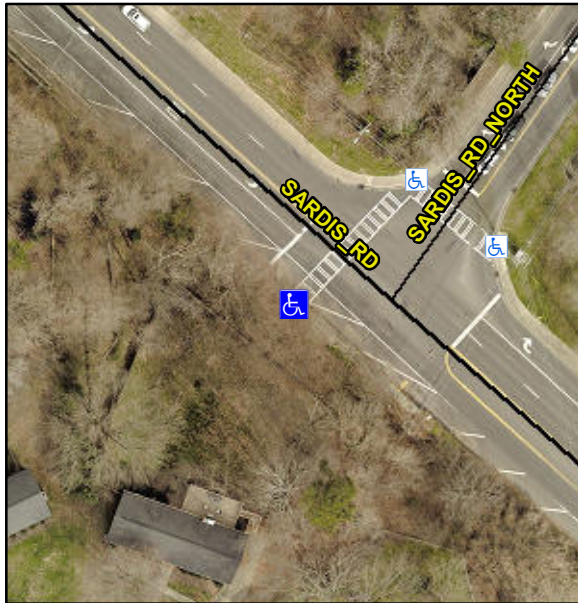
| Compliance | Description | Data | Compliance | Description | Data |
|---|---|---|---|---|---|
| | | | No | Curb Slope (%) | 13.3 |

**Remove & Replace Curb Slope and Extend Ramp.**
