Access Compliance Report Public Rights-of-Way (Curb Ramps)

Intersection ID: 2801 Main Street: BELL'S MILL DR **Cross Street: DUNOON LN** Location: W Initial Pass/Fail: Fail **Overall Compliance: No** 10 ADA ID: 0608F57368EE Ramp Type: Perp **Severity Score:**

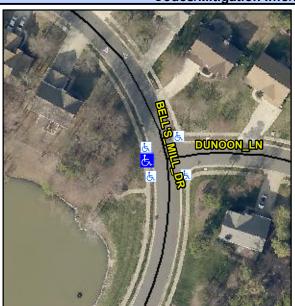
Compliance Description <u>Data</u> Compliance Description Data Yes Ramp Slope (%) N/A Ramp Length (in) 48.0 5.5 Yes Ramp XSlope (%) No Ramp Width (in) 36.0 2.3 N/A N/A Flare Type LT N/A Flare Type RT N/A N/A N/A Flare Slope RT (%) Flare Slope LT (%) N/A N/A N/A Flare Traversable LT? N/A N/A Flare Traversable RT? N/A N/A N/A N/A **DWS Provided?** Landing Length (in) N/A N/A Landing Width (in) N/A N/A **DWS Contrast?** N/A N/A N/A Landing Slope (%) N/A DWS Length (in) N/A N/A Landing X Slope (%) N/A N/A DWS Full Width? N/A N/A Landing Curb? (Y/N) N/A N/A DWS Offset (in) N/A N/A N/A Shared Landing? N/A **Gutter Ponding?** N/A N/A Gutter Slope (%) N/A N/A Gutter Lip Ht (in) N/A N/A Gutter X Slope (%) N/A N/A Painted X Walk1? No N/A Painted X Walk2? N/A X Walk 1 Direction To E X Walk 2 Direction N/A N/A N/A X Walk 1 Width (in) X Walk 2 Width (in) N/A X Walk 1 Slope (%) X Walk 2 Slope (%) N/A 5.4 X Walk 1 X Slope (%) 3.2 X Walk 2 X Slope (%) N/A N/A N/A N/A Ramp inside XWalk1? Ramp inside XWalk2? N/A Road Slope (%) N/A N/A Clear Space? N/A Road X Slope (%) N/A N/A Clear Space to XWalk (in) N/A N/A N/A Any Obstructions? N/A Storm Grate/Utility Hazard? N/A **Obstruction Type** Storm Grate/Utility Type N/A N/A

Possible Solutions: Remove & Replace Entire Ramp. Surveyor Notes: N/A PROW/ADA: Not Found, R304.5.1
