Access Compliance Report Public Rights-of-Way (Curb Ramps)

Intersection ID: N/A	Main Street: COSTIGAN_LN			Cross	Street:	N/A	Location:	SE		
ADA ID: 061D3781082A	A Ramp Type: Perp			Initial	Pass/Fa	ail: Fail Overall	o Severity Score:	33.75		
Codes/Mitigation Info/Possible Solution					Field Measurements/Component Compliance					
BALLANTY	ANTYNE COMMONS PY	Possible Solutions:			Compliance Description Date			a Compliance Description		Data
The second second		Remove & Re	place Entire Ram	p.	N/A	Ramp Length (in)	60.0	Yes	Ramp Slope (%)	6.7
the West	e Guerra Asternation		•		No	Ramp Width (in)	41.0	No	Ramp XSlope (%)	8.1

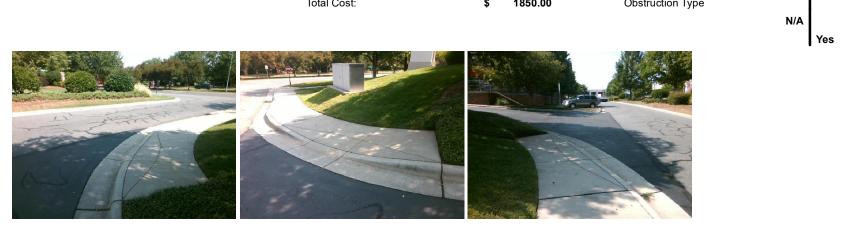
-			N/A	Landing X Slope (%)	N/A	N/A	DWS Full Width?	N/A
	and the second se				N/A	Landing Curb? (Y/N)	N/A	N/A	DWS Offset (in)	N/A
					N/A	Shared Landing?	N/A			
471 4 6		PROW/ADA:			N/A	Gutter Ponding?	N/A	N/A	Gutter Slope (%)	N/A
		Not Found, F	R304.5.1, R304.5.3		N/A	Gutter Lip Ht (in)	N/A	N/A	Gutter X Slope (%)	N/A
			····, ····		N/A	Painted X Walk1?	No	N/A	Painted X Walk2?	N/A
						X Walk 1 Direction	To SW		X Walk 2 Direction	N/A
					N/A	X Walk 1 Width (in)	N/A	N/A	X Walk 2 Width (in)	N/A
Street 1 Name	ENTRANCE					X Walk 1 Slope (%)	3.5		X Walk 2 Slope (%)	N/A
Stop Condition-Street 2	StopSign					X Walk 1 X Slope (%)	7.0		X Walk 2 X Slope (%)	N/A
Street 2 Name	N/A				N/A	Ramp inside XWalk1?	N/A	N/A	Ramp inside XWalk2?	N/A
Stop Condition-Street 1	N/A					Road Slope (%)	N/A	N/A	Clear Space?	N/A
						Road X Slope (%)	N/A	N/A	Clear Space to XWalk (in)	N/A
					N/A	Any Obstructions?	N/A	N/A	Storm Grate/Utility Hazard?	N/A

Total Cost:	\$	1850.00		Obstruction Type			Storm Grate/Utility Type	
							N/A			N/A
