# Access Compliance Report

## Public Rights-of-Way

| Intersection ID: 10065 | Main Street: COMMERCIAL_AV | Cross Street: THE_PLAZA | Location: SW |
| ADA ID: 061FDE1BC123 | Ramp Type: Directional1 | Initial Pass/Fail: Pass | Overall Compliance: No |

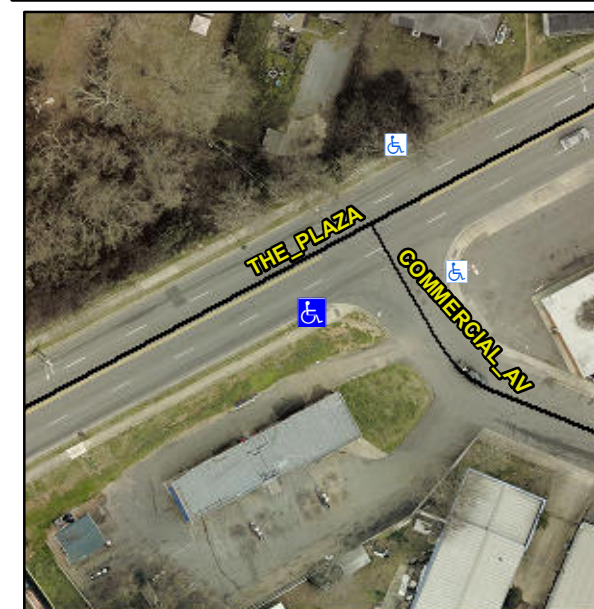
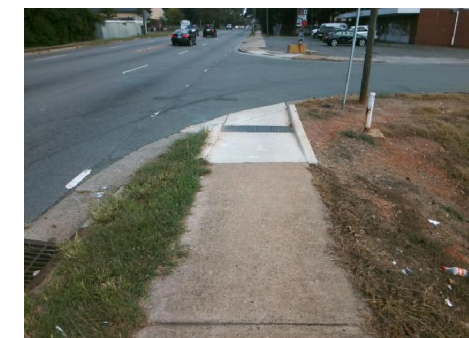
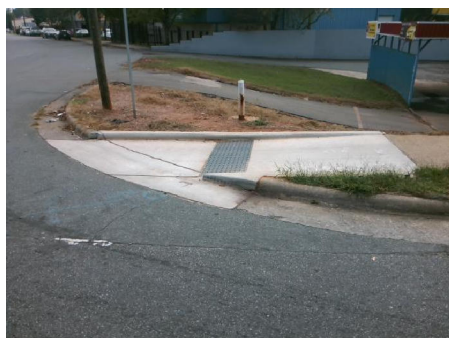
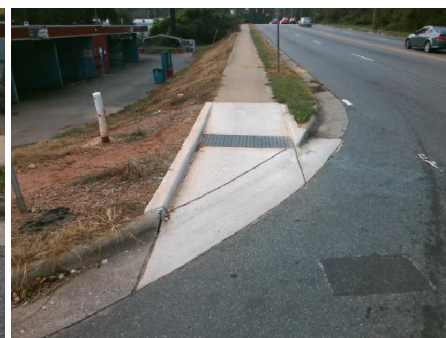
| Severity Score: 7.5 | | | |

**Not Found, R305.2, R302.7.2,  
R304.5.3**

| Compliance | Description | Data | Compliance | Description | Data |
|---|---|---|---|---|---|
| No | Gutter Lip Ht (in) | 0.5 | No | Gutter X Slope (%) | 3.0 |

**Remove & Replace Entire Ramp.  
Remove & Replace Gutter.**
