| Intersection ID: 27369 | Main Street: JORDAN_RAE_LN | Cross Street: MEADOW_RUN_LN | Location: | SE |
| ADA ID: 062388689ED0 | Ramp Type: BlendTrans2 | Initial Pass/Fail: Fail | Overall Compliance: No | Severity Score: 8.75 |

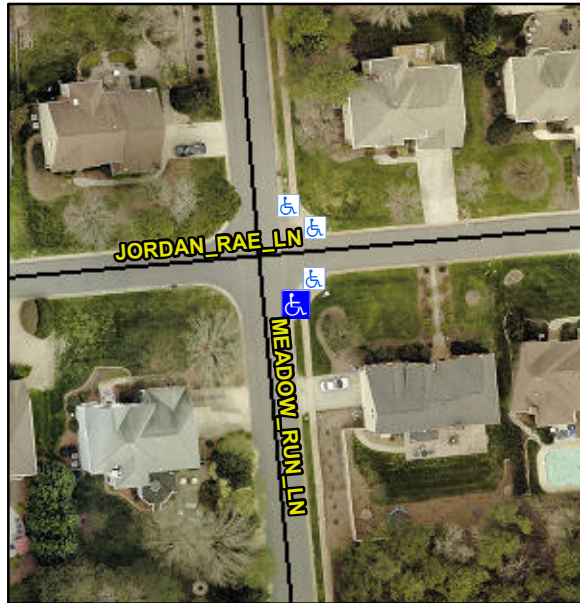
**Not Found, R304.5.1**

| Compliance | Description | Data | Compliance | Description | Data |
|---|---|---|---|---|---|
| No | Ramp Width (in) | 40.0 | Yes | BlendTrans XSlope (%) | 0.4 |
| | | | No | Curb Slope (%) | 7.8 |

**Remove & Replace Curb Ramp With Two New Directional Ramps or Equivalent.**
