Access Compliance Report

Public Rights-of-Way

(Curb Ramps)

Intersection ID: N/A	Main Street: AGNEW_DR	Cross Street: COWGILL_LN	Location: SW
ADA ID: 0627F2535CD6	Ramp Type: Perp	Initial Pass/Fail: Fail	Overall Compliance: No
Severity Score: 8.75			
Codes/Mitigation Info/Possible Solution		Field Measurements/Component Compliance

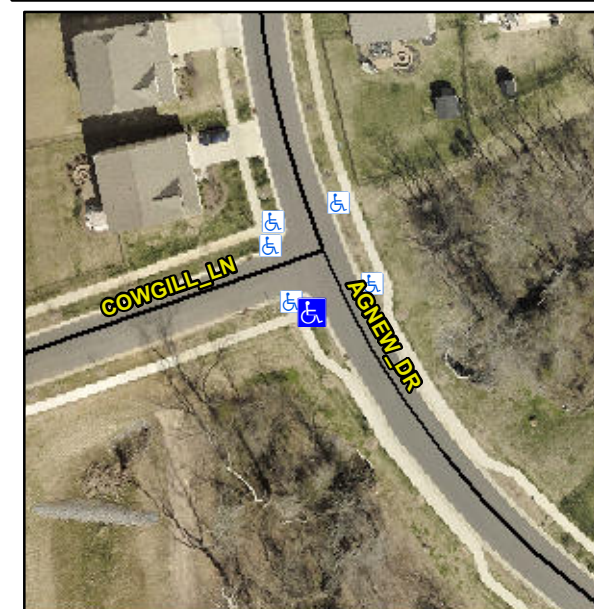
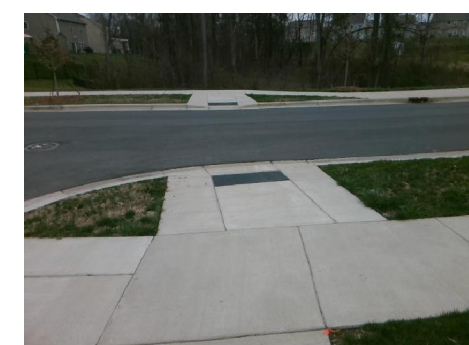
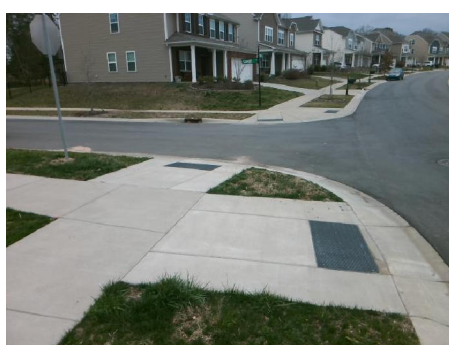
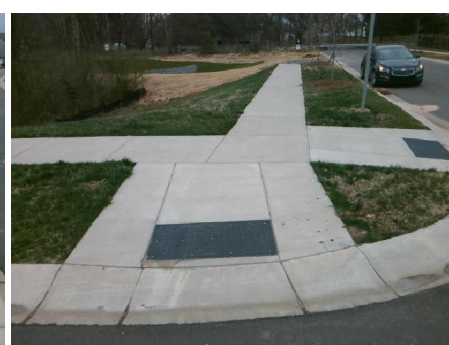
Not Found, R304.5.1

Compliance	Description	Data	Compliance	Description	Data
N/A	Ramp Length (in)	96.0	Yes	Ramp Slope (%)	5.6
No	Ramp Width (in)	47.0	Yes	Ramp XSlope (%)	0.3
N/A	Flare Type LT	N/A	N/A	Flare Type RT	N/A
N/A	Flare Slope LT (%)	N/A	N/A	Flare Slope RT (%)	N/A
N/A	Flare Traversable LT?	N/A	N/A	Flare Traversable RT?	N/A
N/A	Landing Length (in)	N/A	N/A	DWS Provided?	N/A
N/A	Landing Width (in)	N/A	N/A	DWS Contrast?	N/A
N/A	Landing Slope (%)	N/A	N/A	DWS Length (in)	N/A
N/A	Landing X Slope (%)	N/A	N/A	DWS Full Width?	N/A
N/A	Landing Curb? (Y/N)	N/A	N/A	DWS Offset (in)	N/A
N/A	Shared Landing?	N/A			
N/A	Gutter Ponding?	N/A	N/A	Gutter Slope (%)	N/A
N/A	Gutter Lip Ht (in)	N/A	N/A	Gutter X Slope (%)	N/A
N/A	Painted X Walk1?	No	N/A	Painted X Walk2?	N/A
	X Walk 1 Direction	To E		X Walk 2 Direction	N/A
N/A	X Walk 1 Width (in)	N/A	N/A	X Walk 2 Width (in)	N/A
	X Walk 1 Slope (%)	3.8		X Walk 2 Slope (%)	N/A
	X Walk 1 X Slope (%)	1.3		X Walk 2 X Slope (%)	N/A

N/A	Ramp inside XWalk1?	N/A	N/A	Ramp inside XWalk2?	N/A
	Road Slope (%)	N/A	N/A	Clear Space?	N/A
	Road X Slope (%)	N/A	N/A	Clear Space to XWalk (in)	N/A
N/A	Any Obstructions?	N/A	N/A	Storm Grate/Utility Hazard?	N/A
	Obstruction Type			Storm Grate/Utility Type	
		N/A			N/A
			Yes	Surface Condition? (G/P)	Good

Remove & Replace Entire Ramp.

Total Cost: \$ 1850.00
