Access Compliance Report Public Rights-of-Way (Curb Ramps)

Intersection ID: 28184Main Street: BLAKENEY_HEATH_RDCross Street: BLAKENEY_PROFESSIONAL_DRLocation:NWADA ID: 062932AB92CDRamp Type: ParaDiagInitial Pass/Fail: FailOverall Compliance: NoSeverity Score: 26.25

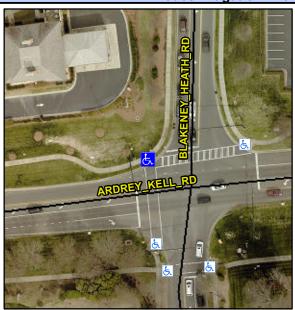
RT RP < 5%

| Compliance Description Data Compliance Description | | | | | |
|---|---|---|---|---|---|
| No | Ramp Slope LT (%) | 13.2 | Yes | Ramp Slope RT (%) | 2.5 |
| No | Ramp XSlope LT (%) | 2.5 | No | Ramp XSlope RT (%) | 3.1 |

Remove & Replace Curb Ramp With
Two New Directional Ramps or
Equivalent.

R304.3.2, R304.5.3
