# Access Compliance Report

## Public Rights-of-Way

### (Curb Ramps)

| Intersection ID: 11642 | Main Street: N_POPLAR_ST | Cross Street: W_9TH_ST | Location: E |

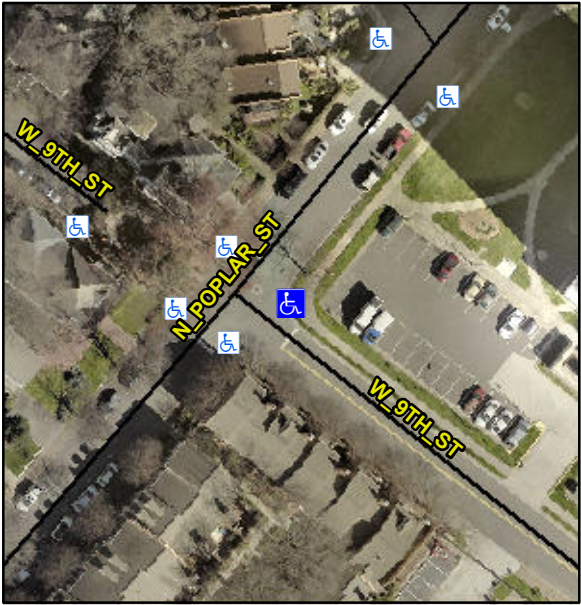
| ADA ID: 0638E78A11C2 | Ramp Type: PerpDiag | Initial Pass/Fail: Fail | Overall Compliance: No |
| | | | Severity Score: 13.75 |

| Codes/Mitigation Info/Possible Solution | | | Field Measurements/Component Compliance | | |
|---|---|--|---|---|---|
| <p>Surveyor Notes:</p> <p><b>N/A</b></p> <p>PROW/ADA:</p> <p><b>R304.2.2, R304.5.3</b></p> | | | N/A | Flare Type RT | N/A |

| Codes/Mitigation Info/Possible Solution | | | Field Measurements/Component Compliance | | |
|---|---|--|---|---|---|
| | <b>Remove &amp; Replace Curb Ramp With Two New Directional Ramps or Equivalent.</b> | | N/A | Ramp Length (in) | 64.0 |
| <p>Total Cost:</p> <p><b>\$ 3200.00</b></p> | | | N/A | Painted X Walk1? | No |
