# Access Compliance Report

## Public Rights-of-Way

### (Curb Ramps)

| Intersection ID: 43844 | Main Street: CURRIER_RD | Cross Street: DELUCA_DR | Location: NW |

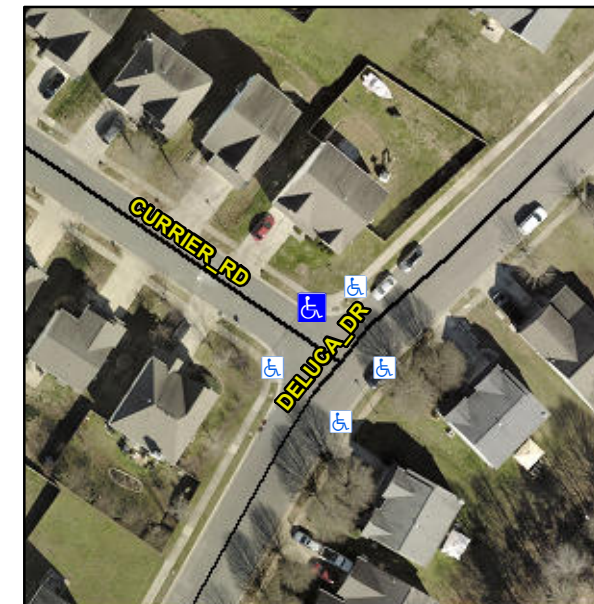
| ADA ID: 0646A96320B1 | Ramp Type: BlendTrans1 | Initial Pass/Fail: Fail | Overall Compliance: No |
| | | Severity Score: 12.5 | |

**Not Found, R304.5.3**

| Compliance | Description | Data | Compliance | Description | Data |
|---|---|---|---|---|---|
| Yes | Ramp Width (in) | 48.0 | No | BlendTrans XSlope (%) | 6.2 |
| | | | No | Curb Slope (%) | 10.8 |

**Remove & Replace Curb Ramp With Two New Directional Ramps or Equivalent.**

Total Cost: \$ 3200.00

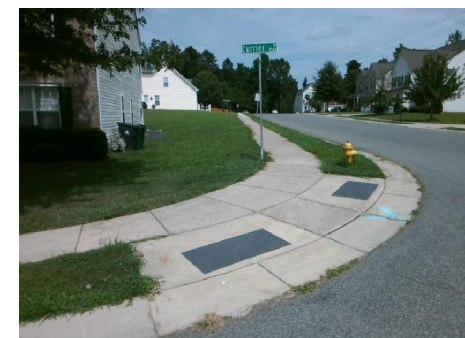
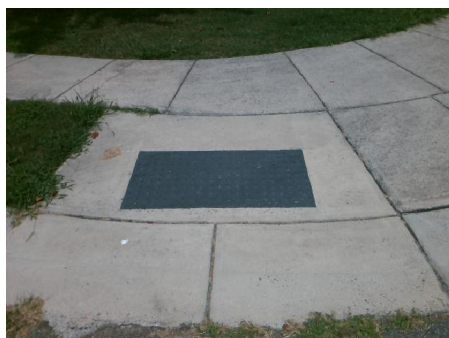
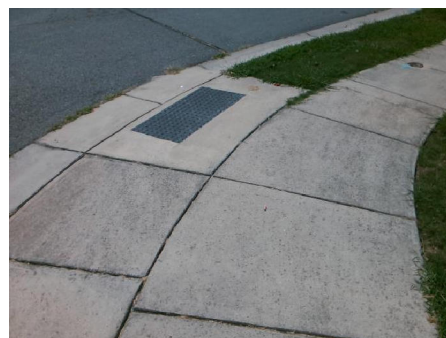
| Compliance | Description | Data | Compliance | Description | Data |
|---|---|---|---|---|---|
| N/A | Ramp Length (in) | 48.0 | Yes | BlendTrans Slope (%) | 4.8 |
| | | | Yes | Surface Condition? (G/P) | Good |
