Access Compliance Report

Public Rights-of-Way

(Curb Ramps)

Intersection ID: 10384	Main Street: E_34TH_ST	Cross Street: N_MYERS_ST	Location: N
ADA ID: 064F9E4ACEA8	Ramp Type: Perp	Initial Pass/Fail: Fail	Overall Compliance: No
Severity Score: 21.25			
Codes/Mitigation Info/Possible Solution		Field Measurements/Component Compliance

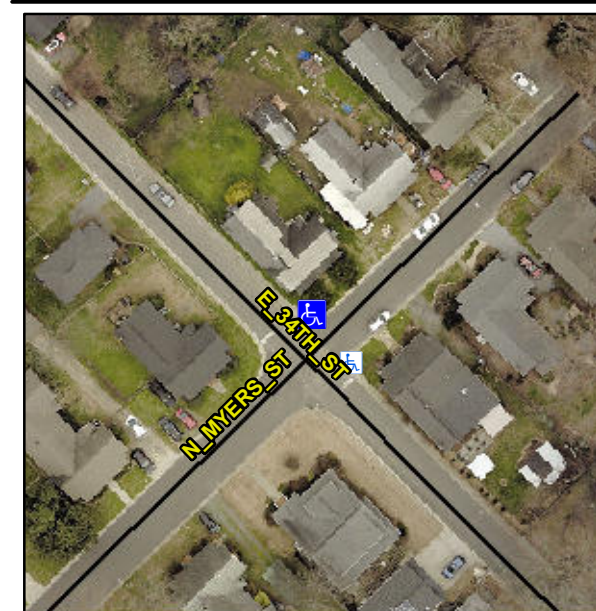
Not Found, R304.5.1, R304.2.2

Compliance	Description	Data	Compliance	Description	Data
N/A	Ramp Length (in)	26.0	No	Ramp Slope (%)	9.4
No	Ramp Width (in)	47.5	Yes	Ramp XSlope (%)	1.4
N/A	Flare Type LT	N/A	N/A	Flare Type RT	N/A
N/A	Flare Slope LT (%)	N/A	N/A	Flare Slope RT (%)	N/A
N/A	Flare Traversable LT?	N/A	N/A	Flare Traversable RT?	N/A
N/A	Landing Length (in)	N/A	N/A	DWS Provided?	N/A
N/A	Landing Width (in)	N/A	N/A	DWS Contrast?	N/A
N/A	Landing Slope (%)	N/A	N/A	DWS Length (in)	N/A
N/A	Landing X Slope (%)	N/A	N/A	DWS Full Width?	N/A
N/A	Landing Curb? (Y/N)	N/A	N/A	DWS Offset (in)	N/A
N/A	Shared Landing?	N/A			
N/A	Gutter Ponding?	N/A	N/A	Gutter Slope (%)	N/A
N/A	Gutter Lip Ht (in)	N/A	N/A	Gutter X Slope (%)	N/A
N/A	Painted X Walk1?	No	N/A	Painted X Walk2?	N/A
	X Walk 1 Direction	To SE		X Walk 2 Direction	N/A
N/A	X Walk 1 Width (in)	N/A	N/A	X Walk 2 Width (in)	N/A
	X Walk 1 Slope (%)	0.1		X Walk 2 Slope (%)	N/A
	X Walk 1 X Slope (%)	5.6		X Walk 2 X Slope (%)	N/A

N/A	Ramp inside XWalk1?	N/A	N/A	Ramp inside XWalk2?	N/A
	Road Slope (%)	N/A	N/A	Clear Space?	N/A
	Road X Slope (%)	N/A	N/A	Clear Space to XWalk (in)	N/A
N/A	Any Obstructions?	N/A	N/A	Storm Grate/Utility Hazard?	N/A
	Obstruction Type			Storm Grate/Utility Type	
		N/A			N/A
			Yes	Surface Condition? (G/P)	Good

Remove & Replace Entire Ramp.
