## Access Compliance Report Public Rights-of-Way (Curb Ramps)

Intersection ID: 19926 Main Street: ARCHDALE\_DR Cross Street: FERNHILL\_DR Location: SW

ADA ID: 065F8AE44CFF Ramp Type: BlendTrans2 Initial Pass/Fail: Fail Overall Compliance: No Severity Score: 25

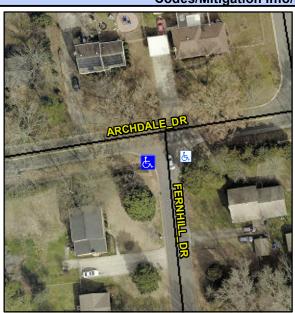
Compliance Description Data Compliance Description Data Yes BlendTrans Slope (%) N/A Ramp Length (in) 63.0 2.3 No Yes Ramp Width (in) 48.0 BlendTrans XSlope (%) 7.9 N/A N/A Flare Type LT N/A Flare Type RT N/A N/A Flare Slope LT (%) N/A N/A Flare Slope RT (%) N/A N/A Flare Traversable LT? N/A N/A Flare Traversable RT? N/A N/A Landing Length (in) N/A N/A DWS Provided? N/A N/A Landing Width (in) N/A N/A **DWS Contrast?** N/A N/A N/A N/A Landing Slope (%) DWS Length (in) N/A N/A Landing X Slope (%) N/A N/A DWS Full Width? N/A N/A Landing Curb? (Y/N) N/A N/A DWS Offset (in) N/A N/A N/A Shared Landing? N/A **Gutter Ponding?** N/A N/A Gutter Slope (%) N/A N/A Gutter Lip Ht (in) N/A N/A Gutter X Slope (%) N/A N/A Painted X Walk1? No N/A Painted X Walk2? No X Walk 1 Direction To E X Walk 2 Direction To N N/A N/A X Walk 1 Width (in) X Walk 2 Width (in) X Walk 1 Slope (%) 7.7 X Walk 2 Slope (%) 0.4 X Walk 1 X Slope (%) 1.1 X Walk 2 X Slope (%) 10.8 N/A N/A Ramp inside XWalk2? N/A Ramp inside XWalk1? N/A Road Slope (%) 6.7 Clear Space? N/A Road X Slope (%) 9.1 N/A Clear Space to XWalk (in) N/A N/A N/A N/A Any Obstructions? Storm Grate/Utility Hazard? N/A **Obstruction Type** Storm Grate/Utility Type N/A N/A Yes Surface Condition? (G/P) Good No Curb Slope (%) 8.8

FERNHILL DR StopSign ARCHDALE DR None Remove & Replace Curb Ramp With Two New Directional Ramps or Equivalent.

PROW/ADA:
Not Found, R304.5.3

Total Cost: \$ 3200.00
