Access Compliance Report

Public Rights-of-Way

(Curb Ramps)

Intersection ID: 10035175	Main Street: QUAIL_HILL_RD	Cross Street: N/A	Location: E
ADA ID: 066E0082AC37	Ramp Type: Perp	Initial Pass/Fail: Fail	Overall Compliance: No
		Severity Score: 12.5

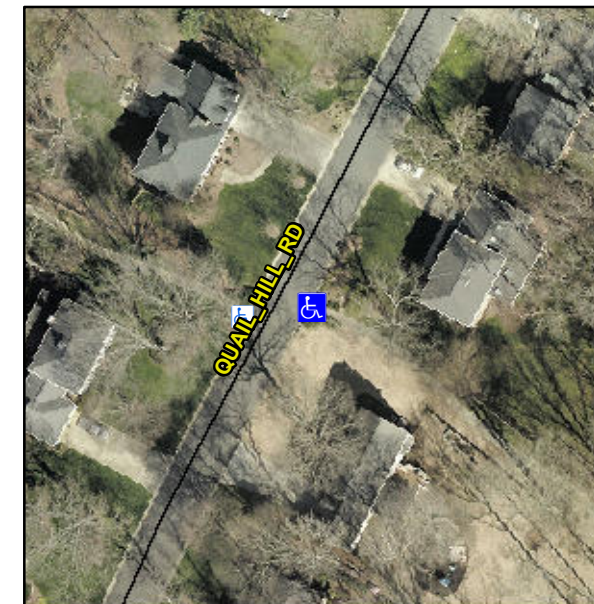
Compliance	Description	Data	Compliance	Description	Data
N/A	Ramp Length (in)	48.0	No	Ramp Slope (%)	8.7
Yes	Ramp Width (in)	48.0	Yes	Ramp XSlope (%)	0.5
N/A	Flare Type LT	N/A	N/A	Flare Type RT	N/A
N/A	Flare Slope LT (%)	N/A	N/A	Flare Slope RT (%)	N/A
N/A	Flare Traversable LT?	N/A	N/A	Flare Traversable RT?	N/A
N/A	Landing Length (in)	N/A	N/A	DWS Provided?	N/A
N/A	Landing Width (in)	N/A	N/A	DWS Contrast?	N/A
N/A	Landing Slope (%)	N/A	N/A	DWS Length (in)	N/A
N/A	Landing X Slope (%)	N/A	N/A	DWS Full Width?	N/A
N/A	Landing Curb? (Y/N)	N/A	N/A	DWS Offset (in)	N/A
N/A	Shared Landing?	N/A			
N/A	Gutter Ponding?	N/A	N/A	Gutter Slope (%)	N/A
N/A	Gutter Lip Ht (in)	N/A	N/A	Gutter X Slope (%)	N/A
N/A	Painted X Walk1?	No	N/A	Painted X Walk2?	N/A
	X Walk 1 Direction	To W		X Walk 2 Direction	N/A
N/A	X Walk 1 Width (in)	N/A	N/A	X Walk 2 Width (in)	N/A
	X Walk 1 Slope (%)	2.3		X Walk 2 Slope (%)	N/A
	X Walk 1 X Slope (%)	0.5		X Walk 2 X Slope (%)	N/A

N/A	Ramp inside XWalk1?	N/A	N/A	Ramp inside XWalk2?	N/A
	Road Slope (%)	N/A	N/A	Clear Space?	N/A
	Road X Slope (%)	N/A	N/A	Clear Space to XWalk (in)	N/A
N/A	Any Obstructions?	N/A	N/A	Storm Grate/Utility Hazard?	N/A
	Obstruction Type			Storm Grate/Utility Type	
		N/A			N/A
			Yes	Surface Condition? (G/P)	Good

Possible Solutions:

Remove & Replace Entire Ramp.

PROW/ADA:

R304.2.2
