Access Compliance Report

Public Rights-of-Way

(Curb Ramps)

Intersection ID: 3340	Main Street: HUCKS_RD	Cross Street: CANIPE_DR	Location: SE
ADA ID: 067C211F4F00	Ramp Type: Perp	Initial Pass/Fail: Fail	Overall Compliance: No
Codes/Mitigation Info/Possible Solution		Field Measurements/Component Compliance	
Severity Score: 21.25

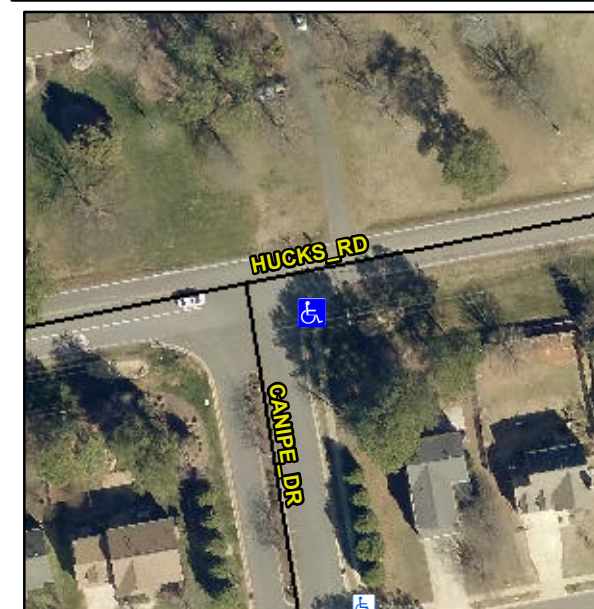
Not Found, R304.5.1, R304.5.3

Compliance	Description	Data	Compliance	Description	Data
N/A	Ramp Length (in)	48.5	Yes	Ramp Slope (%)	8.0
No	Ramp Width (in)	42.0	No	Ramp XSlope (%)	5.7
N/A	Flare Type LT	N/A	N/A	Flare Type RT	N/A
N/A	Flare Slope LT (%)	N/A	N/A	Flare Slope RT (%)	N/A
N/A	Flare Traversable LT?	N/A	N/A	Flare Traversable RT?	N/A
N/A	Landing Length (in)	N/A	N/A	DWS Provided?	N/A
N/A	Landing Width (in)	N/A	N/A	DWS Contrast?	N/A
N/A	Landing Slope (%)	N/A	N/A	DWS Length (in)	N/A
N/A	Landing X Slope (%)	N/A	N/A	DWS Full Width?	N/A
N/A	Landing Curb? (Y/N)	N/A	N/A	DWS Offset (in)	N/A
N/A	Shared Landing?	N/A			
N/A	Gutter Ponding?	N/A	N/A	Gutter Slope (%)	N/A
N/A	Gutter Lip Ht (in)	N/A	N/A	Gutter X Slope (%)	N/A
N/A	Painted X Walk1?	No	N/A	Painted X Walk2?	N/A
	X Walk 1 Direction	To N		X Walk 2 Direction	N/A
N/A	X Walk 1 Width (in)	N/A	N/A	X Walk 2 Width (in)	N/A
	X Walk 1 Slope (%)	9.7		X Walk 2 Slope (%)	N/A
	X Walk 1 X Slope (%)	3.1		X Walk 2 X Slope (%)	N/A

N/A	Ramp inside XWalk1?	N/A	N/A	Ramp inside XWalk2?	N/A
	Road Slope (%)	N/A	N/A	Clear Space?	N/A
	Road X Slope (%)	N/A	N/A	Clear Space to XWalk (in)	N/A
N/A	Any Obstructions?	N/A	N/A	Storm Grate/Utility Hazard?	N/A
	Obstruction Type			Storm Grate/Utility Type	
		N/A			N/A
			Yes	Surface Condition? (G/P)	Good

Remove & Replace Entire Ramp.
