Access Compliance Report

Public Rights-of-Way

(Curb Ramps)

Intersection ID: 11963	Main Street: S_GRAHAM_ST	Cross Street: W_4TH_ST	Location: S
ADA ID: 067FCCF69B3C	Ramp Type: Perp	Initial Pass/Fail: Fail	Overall Compliance: No
Severity Score: 21.25			
Codes/Mitigation Info/Possible Solution		Field Measurements/Component Compliance

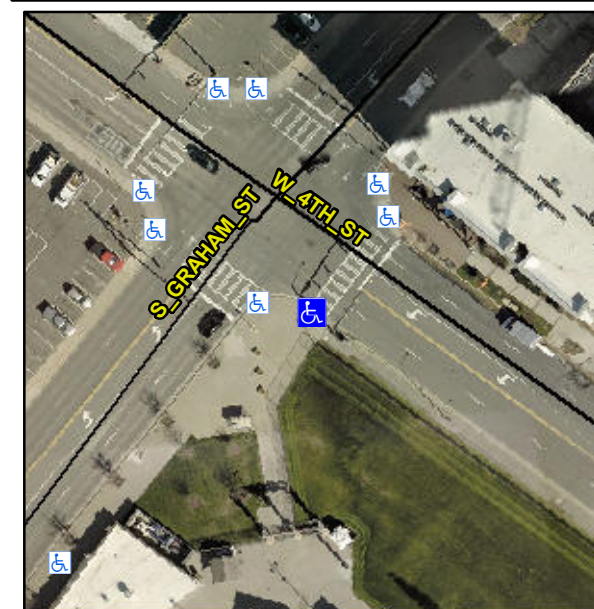
Not Found, R304.5.1, R304.2.2

Compliance	Description	Data	Compliance	Description	Data
N/A	Ramp Length (in)	80.0	No	Ramp Slope (%)	10.4
No	Ramp Width (in)	47.5	Yes	Ramp XSlope (%)	0.2
N/A	Flare Type LT	N/A	N/A	Flare Type RT	N/A
N/A	Flare Slope LT (%)	N/A	N/A	Flare Slope RT (%)	N/A
N/A	Flare Traversable LT?	N/A	N/A	Flare Traversable RT?	N/A
N/A	Landing Length (in)	N/A	N/A	DWS Provided?	N/A
N/A	Landing Width (in)	N/A	N/A	DWS Contrast?	N/A
N/A	Landing Slope (%)	N/A	N/A	DWS Length (in)	N/A
N/A	Landing X Slope (%)	N/A	N/A	DWS Full Width?	N/A
N/A	Landing Curb? (Y/N)	N/A	N/A	DWS Offset (in)	N/A
N/A	Shared Landing?	N/A			
N/A	Gutter Ponding?	N/A	N/A	Gutter Slope (%)	N/A
N/A	Gutter Lip Ht (in)	N/A	N/A	Gutter X Slope (%)	N/A
N/A	Painted X Walk1?	Yes	N/A	Painted X Walk2?	N/A
	X Walk 1 Direction	To NE		X Walk 2 Direction	N/A
N/A	X Walk 1 Width (in)	111.0	N/A	X Walk 2 Width (in)	N/A
	X Walk 1 Slope (%)	0.4		X Walk 2 Slope (%)	N/A
	X Walk 1 X Slope (%)	0.1		X Walk 2 X Slope (%)	N/A

N/A	Ramp inside XWalk1?	Yes	N/A	Ramp inside XWalk2?	N/A
	Road Slope (%)	N/A	N/A	Clear Space?	N/A
	Road X Slope (%)	N/A	N/A	Clear Space to XWalk (in)	N/A
N/A	Any Obstructions?	N/A	N/A	Storm Grate/Utility Hazard?	N/A
	Obstruction Type			Storm Grate/Utility Type	
		N/A			N/A
			Yes	Surface Condition? (G/P)	Good

Remove & Replace Entire Ramp.
