# Access Compliance Report

## Public Rights-of-Way

### (Curb Ramps)

Intersection ID: 10162	Main Street: E_SUGAR_CREEK_RD	Cross Street: THE_PLAZA	Location: SE
ADA ID: 068AB04377BC	Ramp Type: PerpDiag	Initial Pass/Fail: Fail	Overall Compliance: No
Severity Score: 25			
Codes/Mitigation Info/Possible Solution		Field Measurements/Component Compliance

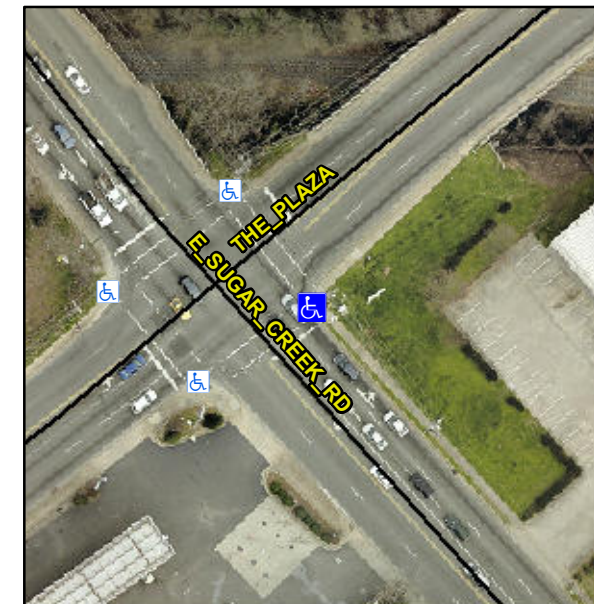
Compliance	Description	Data	Compliance	Description	Data
N/A	Ramp Length (in)	25.5	Yes	Ramp Slope (%)	5.2
Yes	Ramp Width (in)	48.0	No	Ramp XSlope (%)	10.9
N/A	Flare Type LT	N/A	N/A	Flare Type RT	N/A
N/A	Flare Slope LT (%)	N/A	N/A	Flare Slope RT (%)	N/A
N/A	Flare Traversable LT?	N/A	N/A	Flare Traversable RT?	N/A
N/A	Landing Length (in)	N/A	N/A	DWS Provided?	N/A
N/A	Landing Width (in)	N/A	N/A	DWS Contrast?	N/A
N/A	Landing Slope (%)	N/A	N/A	DWS Length (in)	N/A
N/A	Landing X Slope (%)	N/A	N/A	DWS Full Width?	N/A
N/A	Landing Curb? (Y/N)	N/A	N/A	DWS Offset (in)	N/A
N/A	Shared Landing?	N/A			
N/A	Gutter Ponding?	N/A	N/A	Gutter Slope (%)	N/A
N/A	Gutter Lip Ht (in)	N/A	N/A	Gutter X Slope (%)	N/A
N/A	Painted X Walk1?	Yes	N/A	Painted X Walk2?	Yes
	X Walk 1 Direction	To NW		X Walk 2 Direction	To SW
N/A	X Walk 1 Width (in)	103.0	N/A	X Walk 2 Width (in)	108.0
	X Walk 1 Slope (%)	7.6		X Walk 2 Slope (%)	1.3
	X Walk 1 X Slope (%)	4.2		X Walk 2 X Slope (%)	7.8

N/A	Ramp inside XWalk1?	Yes	N/A	Ramp inside XWalk2?	Yes
	Road Slope (%)	6.8	N/A	Clear Space?	N/A
	Road X Slope (%)	5.5	N/A	Clear Space to XWalk (in)	N/A
N/A	Any Obstructions?	N/A	N/A	Storm Grate/Utility Hazard?	N/A
	Obstruction Type			Storm Grate/Utility Type	
		N/A			N/A
		Yes		Surface Condition? (G/P)	Good

**Remove & Replace Curb Ramp With Two New Directional Ramps or Equivalent.**
