Access Compliance Report

Public Rights-of-Way

(Curb Ramps)

Intersection ID: 12979	Main Street: CENTRAL_AV	Cross Street: HEATH_CT	Location: NE
ADA ID: 068AE7A90265	Ramp Type: Perp	Initial Pass/Fail: Fail	Overall Compliance: No
Severity Score: 22.5			
Codes/Mitigation Info/Possible Solution		Field Measurements/Component Compliance

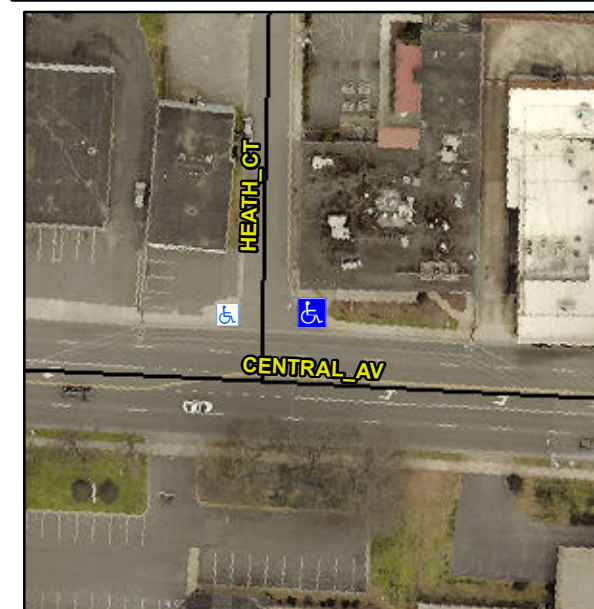
Not Found, R304.5.1, R304.2.2, R304.5.3

Compliance	Description	Data	Compliance	Description	Data
N/A	Ramp Length (in)	61.0	No	Ramp Slope (%)	9.0
No	Ramp Width (in)	43.0	No	Ramp XSlope (%)	3.1
N/A	Flare Type LT	N/A	N/A	Flare Type RT	N/A
N/A	Flare Slope LT (%)	N/A	N/A	Flare Slope RT (%)	N/A
N/A	Flare Traversable LT?	N/A	N/A	Flare Traversable RT?	N/A
N/A	Landing Length (in)	N/A	N/A	DWS Provided?	N/A
N/A	Landing Width (in)	N/A	N/A	DWS Contrast?	N/A
N/A	Landing Slope (%)	N/A	N/A	DWS Length (in)	N/A
N/A	Landing X Slope (%)	N/A	N/A	DWS Full Width?	N/A
N/A	Landing Curb? (Y/N)	N/A	N/A	DWS Offset (in)	N/A
N/A	Shared Landing?	N/A			
N/A	Gutter Ponding?	N/A	N/A	Gutter Slope (%)	N/A
N/A	Gutter Lip Ht (in)	N/A	N/A	Gutter X Slope (%)	N/A
N/A	Painted X Walk1?	No	N/A	Painted X Walk2?	N/A
	X Walk 1 Direction	To W		X Walk 2 Direction	N/A
N/A	X Walk 1 Width (in)	N/A	N/A	X Walk 2 Width (in)	N/A
	X Walk 1 Slope (%)	3.5		X Walk 2 Slope (%)	N/A
	X Walk 1 X Slope (%)	1.5		X Walk 2 X Slope (%)	N/A

Remove & Replace Entire Ramp.
