# Access Compliance Report

## Public Rights-of-Way

### (Curb Ramps)

| Intersection ID: 15017 | Main Street: BALTIMORE_AV | Cross Street: GRIFFITH_ST | Location: E |

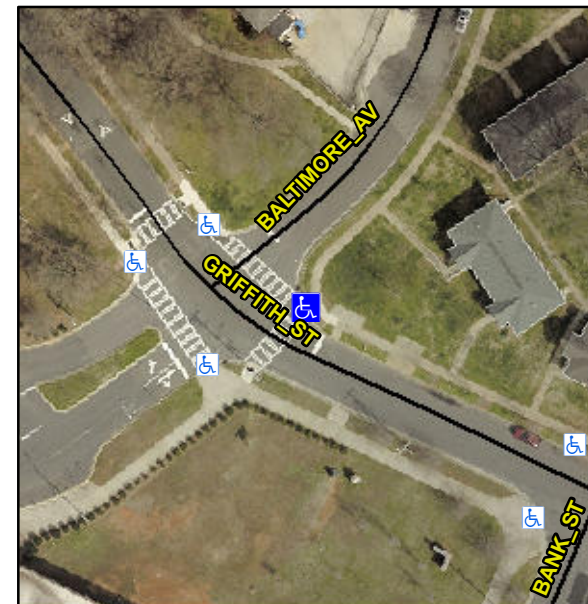
**R304.5.3, R304.2.1, R304.2.2-Perp, R304.3.2-Para, R305**

| Compliance | Description | Data | Compliance | Description | Data |
|---|---|---|---|---|---|
| Yes | Ramp Width (in) | 51.0 | No | Ramp XSlope (%) | 3.0 |
| No | Landing Length (in) | N/A | No | DWS Provided? | No |
| No | Landing Width (in) | N/A | N/A | DWS Contrast? | No |
| No | Landing Slope (%) | N/A | N/A | DWS Length (in) | N/A |
| No | Landing X Slope (%) | N/A | N/A | DWS Full Width? | No |

**Remove & Replace Curb Ramp With Two New Directional Ramps or Equivalent.**

Total Cost: \$ 3200.00
