Access Compliance Report

Public Rights-of-Way

(Curb Ramps)

Intersection ID: 54470	Main Street: PETE_BROWN_RD	Cross Street: FOX_POINT_DR	Location: SW
ADA ID: 0690CF90AFC0	Ramp Type: Directional	Initial Pass/Fail: Fail	Overall Compliance: No
			Severity Score: 13.75

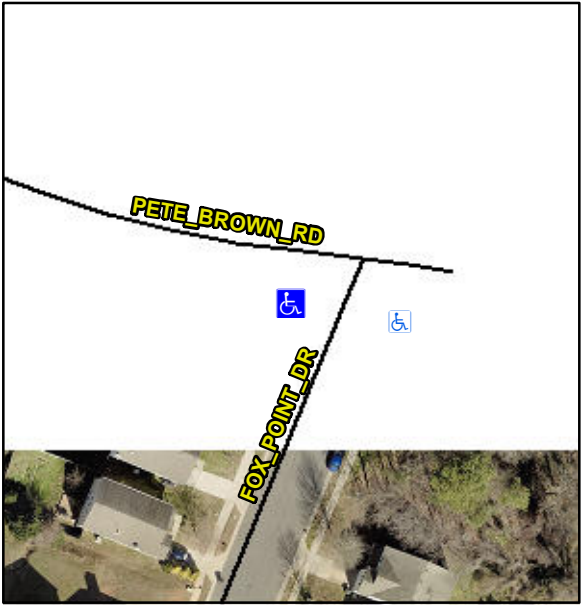
<p>Street 1 Name: FOX POINT DR</p> <p>Stop Condition-Street 1: StopSign</p> <p>Street 2 Name: N/A</p> <p>Stop Condition-Street 2: N/A</p>	Possible Solutions:	Compliance	Description	Data	Compliance	Description	Data
	Remove & Replace Entire Ramp.	N/A	Ramp Length (in)	36.0	N/A	Grade Break?	N/A
		Yes	Ramp Width (in)	71.5	N/A	Grade Break Slope (%)	0.0
		No	Ramp Slope (%)	8.7	N/A	Grade Break XSlope (%)	0.0
		No	Ramp XSlope (%)	2.2			
		N/A	Flare Type LT	N/A	N/A	Flare Type RT	N/A
		N/A	Flare Slope LT (%)	N/A	N/A	Flare Slope RT (%)	0.0
		N/A	Flare Traversable LT?	N/A	N/A	Flare Traversable RT?	N/A
		N/A	Landing Length (in)	0.0	N/A	DWS Provided?	N/A
		N/A	Landing Width (in)	0.0	N/A	DWS Contrast?	N/A
		N/A	Landing Slope (%)	0.0	N/A	DWS Length (in)	N/A
		N/A	Landing X Slope (%)	0.0	N/A	DWS Full Width?	N/A
		N/A	Landing Curb? (Y/N)	N/A	N/A	DWS Offset LT (in)	N/A

N/A	Shared Landing?	N/A	N/A	DWS Offset RT (in)	N/A
		N/A	Gutter Ponding?	0.0	N/A	Gutter Slope (%)	N/A
		N/A	Gutter Lip Ht (in)	0.0	N/A	Gutter X Slope (%)	N/A
		N/A	Painted X Walk1?	No		Road Slope (%)	1.6
			X Walk 1 Direction	To NE		Road X Slope (%)	4.4
			X Walk 1 Width (in)	N/A		Clear Space?	N/A
			X Walk 1 Slope (%)	1.6	N/A	Clear Space to XWalk (in)	N/A
			X Walk 1 X Slope (%)	4.4	N/A	Storm Grate/Utility Hazard?	N/A
		N/A	Ramp inside XWalk1?	N/A		Storm Grate/Utility Type	
		N/A	Any Obstructions?	N/A			N/A
			Obstruction Type		Yes	Surface Condition? (G/P)	Good
					N/A	Curb Slope (%)	N/A
Total Cost:		\$	1600.00
