# Access Compliance Report

## Public Rights-of-Way

### (Curb Ramps)

| Intersection ID: 20624 | Main Street: BRAMBLEWOOD_DR | Cross Street: W_ARROWWOOD_RD | Location: NW |

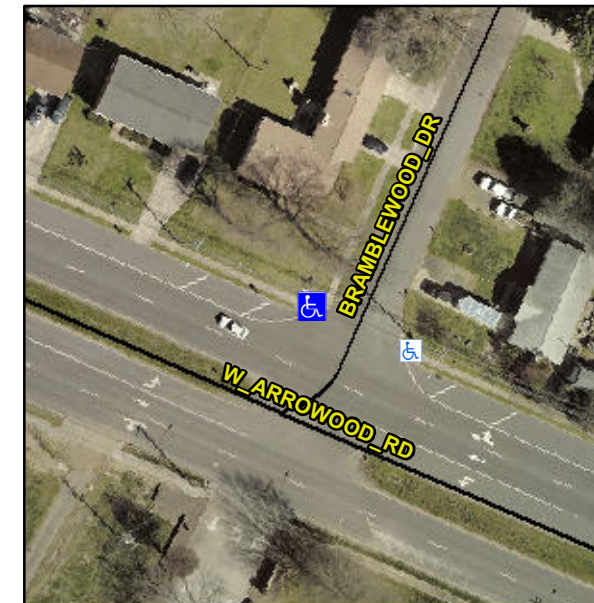
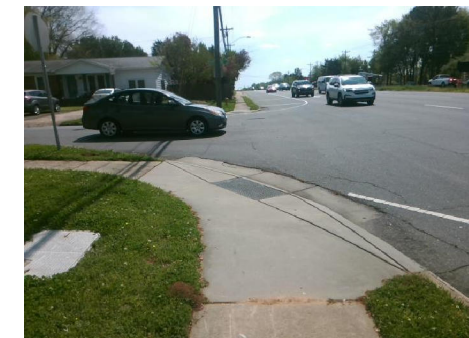
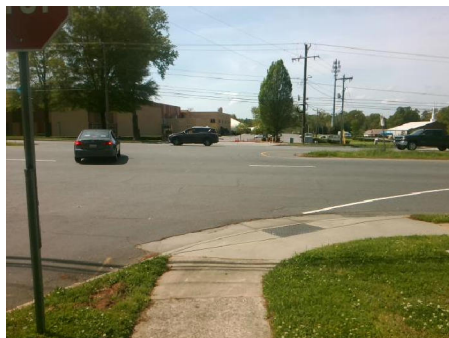
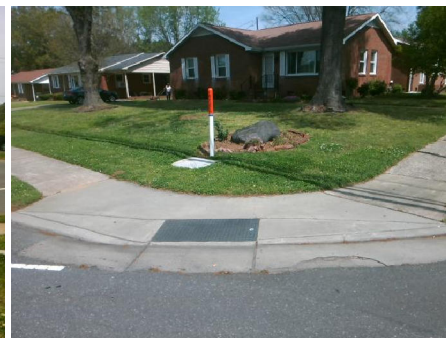
| ADA ID: 06933AB97EA6 | Ramp Type: PerpDiag | Initial Pass/Fail: Pass | Overall Compliance: No |
| | | | Severity Score: 10.25 |

**Not Found, R304.5.3, R304.2.1, R304.2.2-Perp, R304.3.2-Para**

| Compliance | Description | Data | Compliance | Description | Data |
|---|---|---|---|---|---|
| Yes | Ramp Width (in) | 48.0 | No | Ramp XSlope (%) | 3.5 |
| No | Landing Length (in) | N/A | Yes | DWS Provided? | Yes |
| Yes | Gutter Lip Ht (in) | 0.0 | No | Gutter X Slope (%) | 3.7 |

**Remove & Replace Curb Ramp With Two New Directional Ramps or Equivalent. Remove & Replace Gutter.**
