# Access Compliance Report

## Public Rights-of-Way

### (Curb Ramps)

Intersection ID: 10014433	Main Street: GRIER_RD	Cross Street: N/A	Location: SE
ADA ID: 06A8C3EC2431	Ramp Type: PerpDiag	Initial Pass/Fail: Pass	Overall Compliance: No
Severity Score: 20.25			
Codes/Mitigation Info/Possible Solution		Field Measurements/Component Compliance

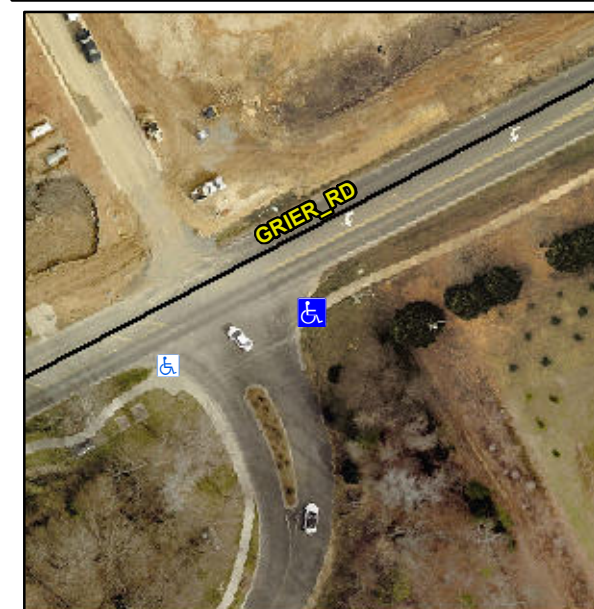
Compliance	Description	Data	Compliance	Description	Data
N/A	Ramp Length (in)	61.0	Yes	Ramp Slope (%)	5.4
Yes	Ramp Width (in)	59.0	No	Ramp XSlope (%)	2.6
N/A	Flare Type LT	Sloped	N/A	Flare Type RT	N/A
N/A	Flare Slope LT (%)	2.4	N/A	Flare Slope RT (%)	8.4
N/A	Flare Traversable LT?	No	N/A	Flare Traversable RT?	No
No	Landing Length (in)	N/A	No	DWS Provided?	No
No	Landing Width (in)	N/A	N/A	DWS Contrast?	No
No	Landing Slope (%)	N/A	N/A	DWS Length (in)	N/A
No	Landing X Slope (%)	N/A	N/A	DWS Full Width?	No
N/A	Landing Curb? (Y/N)	No	N/A	DWS Offset (in)	N/A
N/A	Shared Landing?	No			
Yes	Gutter Ponding?	No	Yes	Gutter Slope (%)	1.2
Yes	Gutter Lip Ht (in)	0.0	Yes	Gutter X Slope (%)	1.4
N/A	Painted X Walk1?	No	N/A	Painted X Walk2?	No
	X Walk 1 Direction	To N		X Walk 2 Direction	To W
N/A	X Walk 1 Width (in)	N/A	N/A	X Walk 2 Width (in)	N/A
	X Walk 1 Slope (%)	1.7		X Walk 2 Slope (%)	3.9
	X Walk 1 X Slope (%)	3.7		X Walk 2 X Slope (%)	1.6

N/A	Ramp inside XWalk1?	N/A	N/A	Ramp inside XWalk2?	N/A
	Road Slope (%)	1.0	N/A	Clear Space?	Yes
	Road X Slope (%)	3.0	N/A	Clear Space to XWalk (in)	N/A
Yes	Any Obstructions?	No	Yes	Storm Grate/Utility Hazard?	No
	Obstruction Type			Storm Grate/Utility Type	
		N/A			N/A
			Yes	Surface Condition? (G/P)	Good

**Remove & Replace Curb Ramp With Two New Directional Ramps or Equivalent.**

**Not Found, R304.5.3, R304.2.1, R304.2.2-Perp, R304.3.2-Para, R305**
