Access Compliance Report

Public Rights-of-Way

(Curb Ramps)

Intersection ID: 13540	Main Street: LEXINGTON_AV	Cross Street: S_CALDWELL_ST	Location: N
ADA ID: 06B339CAB31B	Ramp Type: PerpDiag	Initial Pass/Fail: Fail	Overall Compliance: No
		Severity Score: 50

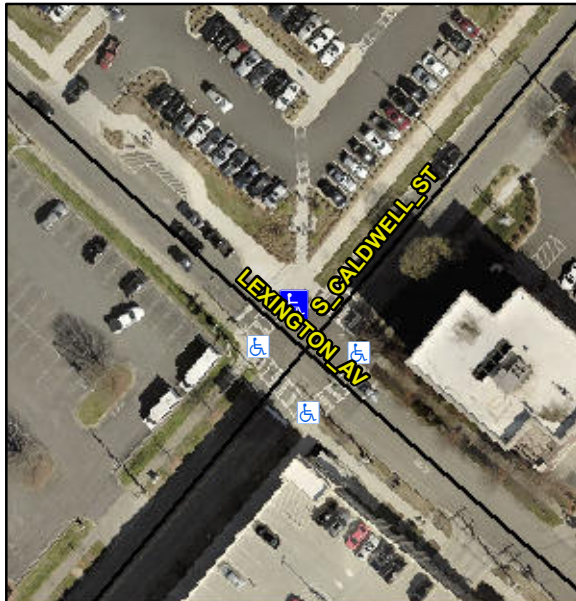
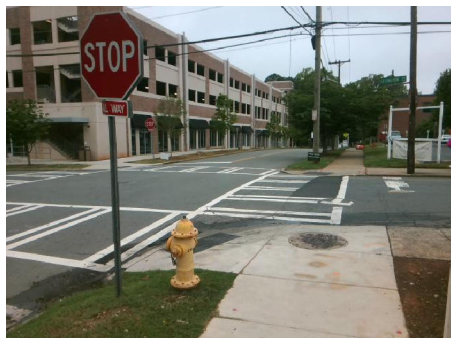
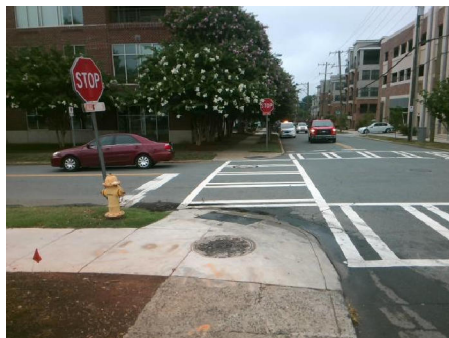
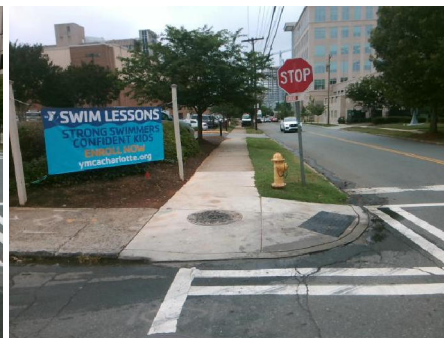
Not Found, R304.2.2, R304.5.3

Compliance	Description	Data	Compliance	Description	Data
N/A	Ramp Length (in)	68.0	No	Ramp Slope (%)	13.9
Yes	Ramp Width (in)	96.0	No	Ramp XSlope (%)	8.7
N/A	Flare Type LT	N/A	N/A	Flare Type RT	N/A
N/A	Flare Slope LT (%)	N/A	N/A	Flare Slope RT (%)	N/A
N/A	Flare Traversable LT?	N/A	N/A	Flare Traversable RT?	N/A
N/A	Landing Length (in)	N/A	N/A	DWS Provided?	N/A
N/A	Landing Width (in)	N/A	N/A	DWS Contrast?	N/A
N/A	Landing Slope (%)	N/A	N/A	DWS Length (in)	N/A
N/A	Landing X Slope (%)	N/A	N/A	DWS Full Width?	N/A
N/A	Landing Curb? (Y/N)	N/A	N/A	DWS Offset (in)	N/A
N/A	Shared Landing?	N/A			
N/A	Gutter Ponding?	Yes	N/A	Gutter Slope (%)	N/A
N/A	Gutter Lip Ht (in)	2.0	N/A	Gutter X Slope (%)	N/A
N/A	Painted X Walk1?	Yes	N/A	Painted X Walk2?	Yes
	X Walk 1 Direction	To SW		X Walk 2 Direction	To SE
N/A	X Walk 1 Width (in)	112.0	N/A	X Walk 2 Width (in)	112.0
	X Walk 1 Slope (%)	4.9		X Walk 2 Slope (%)	0.2
	X Walk 1 X Slope (%)	2.2		X Walk 2 X Slope (%)	3.7

N/A	Ramp inside XWalk1?	Yes	N/A	Ramp inside XWalk2?	Yes
	Road Slope (%)	4.8	N/A	Clear Space?	N/A
	Road X Slope (%)	4.4	N/A	Clear Space to XWalk (in)	N/A
N/A	Any Obstructions?	N/A	N/A	Storm Grate/Utility Hazard?	N/A
	Obstruction Type			Storm Grate/Utility Type	
		N/A			N/A
		Yes		Surface Condition? (G/P)	Good

Remove & Replace Curb Ramp With Two New Directional Ramps or Equivalent.
