# Access Compliance Report

## Public Rights-of-Way

Intersection ID: 4758	Main Street: ARKLOW_RD	Cross Street: BEAKER_CT	Location:	S
ADA ID: 06B4B54876D3	Ramp Type: Perp	Initial Pass/Fail: Fail	Overall Compliance: No	Severity Score: 21.25

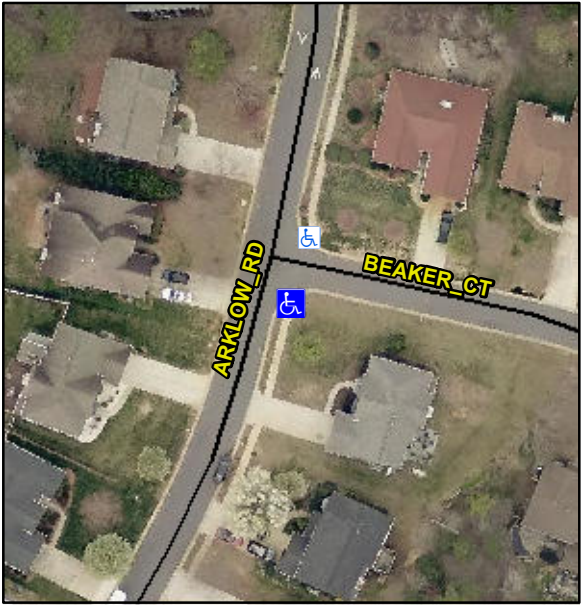
Possible Solutions:		<b>Compliance</b>	<b>Description</b>	<b>Data</b>
	Remove & Replace Entire Ramp.		N/A	Ramp Length (in)	46.0
			No	Ramp Width (in)	47.0
			N/A	Flare Type LT	N/A
			N/A	Flare Slope LT (%)	N/A
			N/A	Flare Traversable LT?	N/A
			N/A	Landing Length (in)	N/A
			N/A	Landing Width (in)	N/A
			N/A	Landing Slope (%)	N/A
			N/A	Landing X Slope (%)	N/A
<p>Surveyor Notes:</p> <p>N/A</p> <p>PROW/ADA:</p> <p>Not Found, R304.5.1, R304.5.3</p>			N/A	Flare Type RT	N/A
			N/A	Flare Slope RT (%)	N/A
			N/A	Flare Traversable RT?	N/A
			N/A	DWS Provided?	N/A
			N/A	DWS Contrast?	N/A
			N/A	DWS Length (in)	N/A
			N/A	DWS Full Width?	N/A
			N/A	DWS Offset (in)	N/A
			N/A	Shared Landing?	N/A
			N/A	Gutter Ponding?	N/A
			N/A	Gutter Lip Ht (in)	N/A
			N/A	Painted X Walk1?	No
				X Walk 1 Direction	To NE
			N/A	X Walk 1 Width (in)	N/A

X Walk 1 Slope (%)	3.6
				X Walk 1 X Slope (%)	1.3
			N/A	Ramp inside XWalk1?	N/A
				Road Slope (%)	N/A
				Road X Slope (%)	N/A
			N/A	Any Obstructions?	N/A
				Obstruction Type	
Total Cost:		\$ 1850.00			
			N/A		N/A
			Yes	Surface Condition? (G/P)	Good
