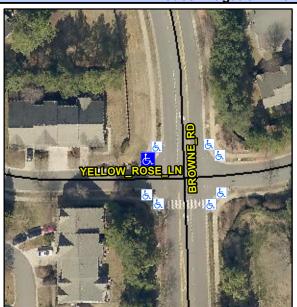
Intersection ID: 2983Main Street: YELLOW_ROSE_LNCross Street: BROWNE_RDLocation:NWADA ID: 06B7459746D0Ramp Type: PerpInitial Pass/Fail: FailOverall Compliance: NoSeverity Score: 22.5

| Field Measurements/Component Compliance | | | | | | |
|---|---|---|---|---|---|--|
| N/A | Ramp Length (in) | 57.0 | No | Ramp Slope (%) | 9.8 | |
| No | Ramp Width (in) | 44.5 | No | Ramp XSlope (%) | 2.8 | |

| POSSIBLE SOLUTION | | | |
|---|---|--|--|
| Remove & Replace Entire Ramp. | N/A | | |
| Restripe Crosswalk. | | | |
| R304.5.1, R304.2.2, R304.5.3 | N/A | | |
