## **Access Compliance Report Public Rights-of-Way** (Curb Ramps)

Intersection ID: 11765 Main Street: VICTORIA\_AV Cross Street: WESTBROOK\_DR Location: NE **Overall Compliance: No** ADA ID: 06B91902CC39 Ramp Type: Perp Initial Pass/Fail: Fail Severity Score: 13.75

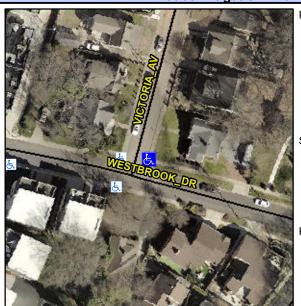
Field Measurements/Component Compliance								
Compl	iance Description	Data	Compli	ance	Description	Data		
N/A	Ramp Length (in)	36.0	No	Ramp	Slope (%)	9.2		
Yes	Ramp Width (in)	60.0	No	Ramp	XSlope (%)	4.5		
N/A	Flare Type LT	N/A	N/A	Flare	Type RT	N/A		
N/A	Flare Slope LT (%)	N/A	N/A	Flare	Slope RT (%)	N/A		
N/A	Flare Traversable LT?	N/A	N/A	Flare	Traversable RT?	N/A		
N/A	Landing Length (in)	N/A	N/A	DWS	Provided?	N/A		
N/A	Landing Width (in)	N/A	N/A	DWS	Contrast?	N/A		
N/A	Landing Slope (%)	N/A	N/A	DWS	Length (in)	N/A		
N/A	Landing X Slope (%)	N/A	N/A	DWS	Full Width?	N/A		
N/A	Landing Curb? (Y/N)	N/A	N/A	DWS	Offset (in)	N/A		
N/A	Shared Landing?	N/A						
N/A	Gutter Ponding?	N/A	N/A	Gutte	r Slope (%)	N/A		
N/A	Gutter Lip Ht (in)	N/A	N/A	Gutte	r X Slope (%)	N/A		
N/A	Painted X Walk1?	No	N/A	Painte	ed X Walk2?	N/A		
	X Walk 1 Direction	To W		X Wa	lk 2 Direction	N/A		
N/A	X Walk 1 Width (in)	N/A	N/A	X Wa	lk 2 Width (in)	N/A

X Walk 1 Slope (%)	1.6		X Wa	lk 2 Slope (%)	N/A		
	X Walk 1 X Slope (%)	2.1		X Wa	lk 2 X Slope (%)	N/A		
N/A	Ramp inside XWalk1?	N/A	N/A	Ramp	inside XWalk2?	N/A		
	Road Slope (%)	N/A	N/A	Clear	Space?	N/A		
	Road X Slope (%)	N/A	N/A	Clear	Space to XWalk (in)	N/A		
N/A	Any Obstructions?	N/A	N/A	Storm	n Grate/Utility Hazard?	N/A		
	Obstruction Type			Storm	n Grate/Utility Type			
		N/A				N/A		
			Yes	Surfa	ce Condition? (G/P)	Good		
	and the second

Possible Solutions:	9
Remove & Replace Entire Ramp.	N
	Y
	N
	N
	N
	N
Surveyor Notes:	N
N/A	N
	N
	N
	N
PROW/ADA:	N
R304.2.2, R304.5.3	N
	ı
	N
	N
