Access Compliance Report

Public Rights-of-Way

(Curb Ramps)

Intersection ID: 43204	Main Street: PLANTAIN_CT	Cross Street: SPEEDWELL_CT	Location: SW
ADA ID: 06B9D6AC244B	Ramp Type: PerpDiag	Initial Pass/Fail: Fail	Overall Compliance: No
		Severity Score: 8.75

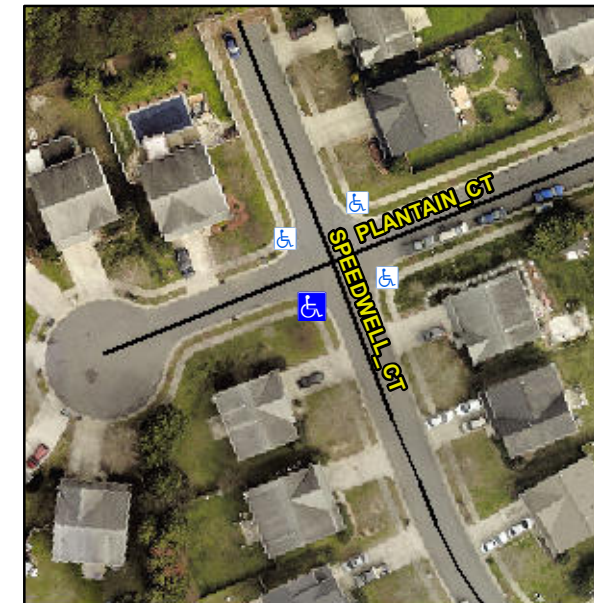
Not Found, R304.5.1

Compliance	Description	Data	Compliance	Description	Data
N/A	Ramp Length (in)	46.0	Yes	Ramp Slope (%)	6.4
No	Ramp Width (in)	40.0	Yes	Ramp XSlope (%)	2.0
N/A	Flare Type LT	N/A	N/A	Flare Type RT	N/A
N/A	Flare Slope LT (%)	N/A	N/A	Flare Slope RT (%)	N/A
N/A	Flare Traversable LT?	N/A	N/A	Flare Traversable RT?	N/A
N/A	Landing Length (in)	N/A	N/A	DWS Provided?	N/A
N/A	Landing Width (in)	N/A	N/A	DWS Contrast?	N/A
N/A	Landing Slope (%)	N/A	N/A	DWS Length (in)	N/A
N/A	Landing X Slope (%)	N/A	N/A	DWS Full Width?	N/A
N/A	Landing Curb? (Y/N)	N/A	N/A	DWS Offset (in)	N/A
N/A	Shared Landing?	N/A			
N/A	Gutter Ponding?	N/A	N/A	Gutter Slope (%)	N/A
N/A	Gutter Lip Ht (in)	N/A	N/A	Gutter X Slope (%)	N/A
N/A	Painted X Walk1?	No	N/A	Painted X Walk2?	No
	X Walk 1 Direction	To E		X Walk 2 Direction	To N
N/A	X Walk 1 Width (in)	N/A	N/A	X Walk 2 Width (in)	N/A
	X Walk 1 Slope (%)	5.6		X Walk 2 Slope (%)	5.2
	X Walk 1 X Slope (%)	5.1		X Walk 2 X Slope (%)	1.9

N/A	Ramp inside XWalk1?	N/A	N/A	Ramp inside XWalk2?	N/A
	Road Slope (%)	0.2	N/A	Clear Space?	N/A
	Road X Slope (%)	8.1	N/A	Clear Space to XWalk (in)	N/A
N/A	Any Obstructions?	N/A	N/A	Storm Grate/Utility Hazard?	N/A
	Obstruction Type			Storm Grate/Utility Type	
		N/A			N/A
		Yes		Surface Condition? (G/P)	Good

Remove & Replace Curb Ramp With Two New Directional Ramps or Equivalent.

Total Cost: \$ 3200.00
