Access Compliance Report

Public Rights-of-Way

(Curb Ramps)

Intersection ID: 11956	Main Street: E_9TH_ST	Cross Street: N_COLLEGE_ST	Location: W
ADA ID: 06C1D18CEE32	Ramp Type: PerpDiag	Initial Pass/Fail: Fail	Overall Compliance: No
Severity Score: 10			
Codes/Mitigation Info/Possible Solution		Field Measurements/Component Compliance

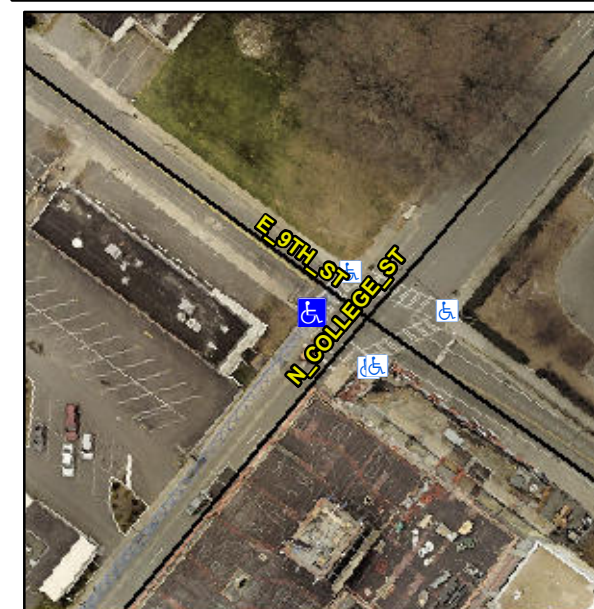
R304.5.1, R304.5.3

Compliance	Description	Data	Compliance	Description	Data
N/A	Ramp Length (in)	95.5	Yes	Ramp Slope (%)	5.9
No	Ramp Width (in)	47.5	No	Ramp XSlope (%)	3.0
N/A	Flare Type LT	N/A	N/A	Flare Type RT	N/A
N/A	Flare Slope LT (%)	N/A	N/A	Flare Slope RT (%)	N/A
N/A	Flare Traversable LT?	N/A	N/A	Flare Traversable RT?	N/A
N/A	Landing Length (in)	N/A	N/A	DWS Provided?	N/A
N/A	Landing Width (in)	N/A	N/A	DWS Contrast?	N/A
N/A	Landing Slope (%)	N/A	N/A	DWS Length (in)	N/A
N/A	Landing X Slope (%)	N/A	N/A	DWS Full Width?	N/A
N/A	Landing Curb? (Y/N)	N/A	N/A	DWS Offset (in)	N/A
N/A	Shared Landing?	N/A			
N/A	Gutter Ponding?	N/A	N/A	Gutter Slope (%)	N/A
N/A	Gutter Lip Ht (in)	N/A	N/A	Gutter X Slope (%)	N/A
N/A	Painted X Walk1?	Yes	N/A	Painted X Walk2?	Yes
	X Walk 1 Direction	To SE		X Walk 2 Direction	To NE
N/A	X Walk 1 Width (in)	95.0	N/A	X Walk 2 Width (in)	95.0
	X Walk 1 Slope (%)	2.6		X Walk 2 Slope (%)	1.9
	X Walk 1 X Slope (%)	1.2		X Walk 2 X Slope (%)	2.5

N/A	Ramp inside XWalk1?	Yes	N/A	Ramp inside XWalk2?	Yes
	Road Slope (%)	2.6	N/A	Clear Space?	N/A
	Road X Slope (%)	2.1	N/A	Clear Space to XWalk (in)	N/A
N/A	Any Obstructions?	N/A	N/A	Storm Grate/Utility Hazard?	N/A
	Obstruction Type			Storm Grate/Utility Type	
		N/A			N/A
		Yes		Surface Condition? (G/P)	Good

Possible Solutions:

Remove & Replace Curb Ramp With Two New Directional Ramps or Equivalent.
