# Access Compliance Report

## Public Rights-of-Way

### (Curb Ramps)

Intersection ID: 29294	Main Street: LOOKING_GLASS_LN	Cross Street: FAR_WEST_DR	Location: SW
ADA ID: 06C2FEB822FC	Ramp Type: PerpDiag	Initial Pass/Fail: Fail	Overall Compliance: No
Codes/Mitigation Info/Possible Solution		Field Measurements/Component Compliance	
Severity Score: 30

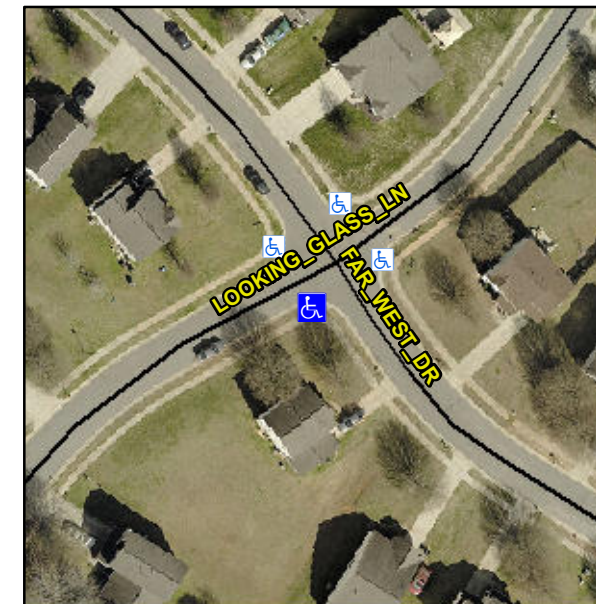
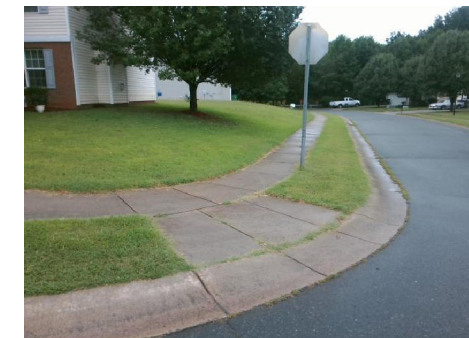
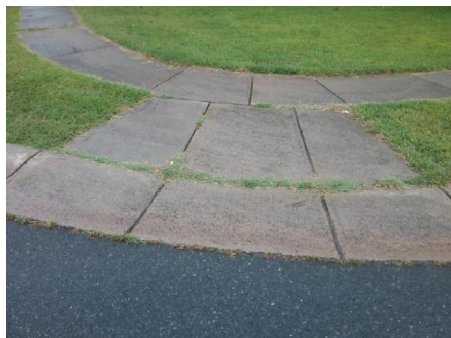
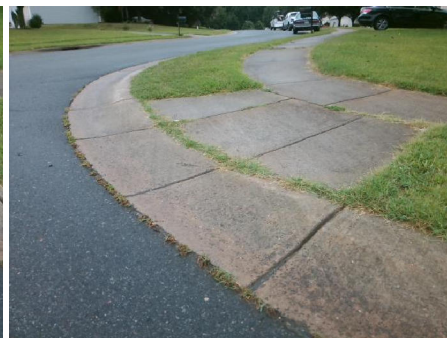
**Not Found, R304.5.1, R304.5.3**

Compliance	Description	Data	Compliance	Description	Data
N/A	Ramp Length (in)	54.5	Yes	Ramp Slope (%)	7.9
No	Ramp Width (in)	32.5	No	Ramp XSlope (%)	6.6
N/A	Flare Type LT	N/A	N/A	Flare Type RT	N/A
N/A	Flare Slope LT (%)	N/A	N/A	Flare Slope RT (%)	N/A
N/A	Flare Traversable LT?	N/A	N/A	Flare Traversable RT?	N/A
N/A	Landing Length (in)	N/A	N/A	DWS Provided?	N/A
N/A	Landing Width (in)	N/A	N/A	DWS Contrast?	N/A
N/A	Landing Slope (%)	N/A	N/A	DWS Length (in)	N/A
N/A	Landing X Slope (%)	N/A	N/A	DWS Full Width?	N/A
N/A	Landing Curb? (Y/N)	N/A	N/A	DWS Offset (in)	N/A
N/A	Shared Landing?	N/A			
N/A	Gutter Ponding?	N/A	N/A	Gutter Slope (%)	N/A
N/A	Gutter Lip Ht (in)	N/A	N/A	Gutter X Slope (%)	N/A
N/A	Painted X Walk1?	No	N/A	Painted X Walk2?	No
	X Walk 1 Direction	To E		X Walk 2 Direction	To W
N/A	X Walk 1 Width (in)	N/A	N/A	X Walk 2 Width (in)	N/A
	X Walk 1 Slope (%)	3.8		X Walk 2 Slope (%)	1.7
	X Walk 1 X Slope (%)	2.0		X Walk 2 X Slope (%)	4.1

N/A	Ramp inside XWalk1?	N/A	N/A	Ramp inside XWalk2?	N/A
	Road Slope (%)	3.4	N/A	Clear Space?	N/A
	Road X Slope (%)	1.4	N/A	Clear Space to XWalk (in)	N/A
N/A	Any Obstructions?	N/A	N/A	Storm Grate/Utility Hazard?	N/A
	Obstruction Type			Storm Grate/Utility Type	
		N/A			N/A
		Yes		Surface Condition? (G/P)	Good

**Remove & Replace Curb Ramp With Two New Directional Ramps or Equivalent.**
