## Access Compliance Report Public Rights-of-Way (Curb Ramps)

Intersection ID: 19240Main Street:GRIFFITH\_RDCross Street:WESTPARK\_DRLocation:NEADA ID: 06C570259319Ramp Type:PerpDiagInitial Pass/Fail:FailOverall Compliance:NoSeverity Score:25

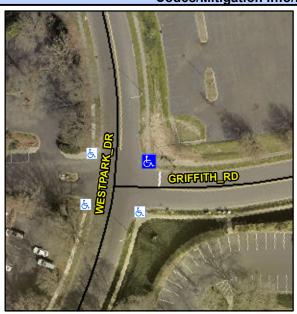
rield Measurements/Component Compilance						
Compliance Description D			Comp	liance Description	Data	
N/A	Ramp Length (in)	112.0	No	Ramp Slope (%)	13.2	
Yes	Ramp Width (in)	48.0	Yes	Ramp XSlope (%)	0.2	
N/A	Flare Type LT	N/A	N/A	Flare Type RT	N/A	
N/A	Flare Slope LT (%)	N/A	N/A	Flare Slope RT (%)	N/A	
N/A	Flare Traversable LT?	N/A	N/A	Flare Traversable RT?	N/A	
N/A	Landing Length (in)	N/A	N/A	DWS Provided?	N/A	
N/A	Landing Width (in)	N/A	N/A	DWS Contrast?	N/A	
N/A	Landing Slope (%)	N/A	N/A	DWS Length (in)	N/A	
N/A	Landing X Slope (%)	N/A	N/A	DWS Full Width?	N/A	
N/A	Landing Curb? (Y/N)	N/A	N/A	DWS Offset (in)	N/A	
N/A	Shared Landing?	N/A				
N/A	Gutter Ponding?	N/A	N/A	Gutter Slope (%)	N/A	
N/A	Gutter Lip Ht (in)	N/A	N/A	Gutter X Slope (%)	N/A	
N/A	Painted X Walk1?	No	N/A	Painted X Walk2?	No	
	X Walk 1 Direction	To NW		X Walk 2 Direction	To SW	
N/A	X Walk 1 Width (in)	N/A	N/A	X Walk 2 Width (in)	N/A	
	X Walk 1 Slope (%)	0.5		X Walk 2 Slope (%)	0.4

Possible Solution
Possible Solutions:
Remove & Replace Curb Ramp With Two New Directional Ramps or Equivalent.
Surveyor Notes:
N/A
PROW/ADA:
R304.2.2
