Access Compliance Report

Public Rights-of-Way

(Curb Ramps)

Intersection ID: 19622	Main Street: SARDIS_RD	Cross Street: SARDIS_VIEW_RD	Location: SE
ADA ID: 06CBAAB1E58D	Ramp Type: PerpDiag	Initial Pass/Fail: Fail	Overall Compliance: No
Severity Score: 37.5			
Codes/Mitigation Info/Possible Solution		Field Measurements/Component Compliance

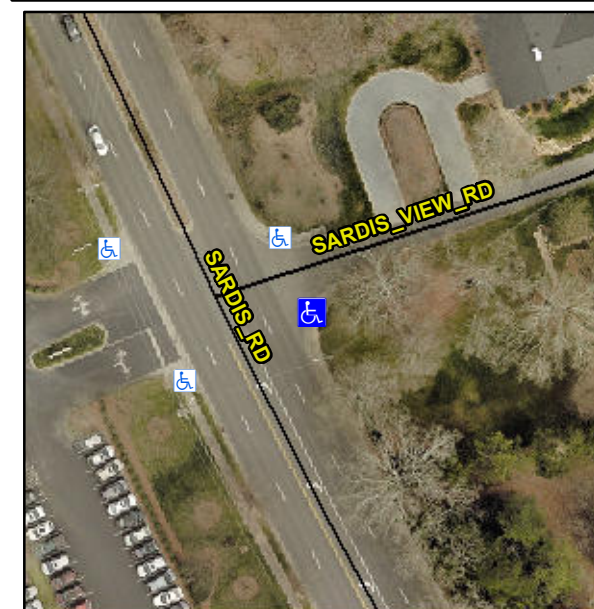
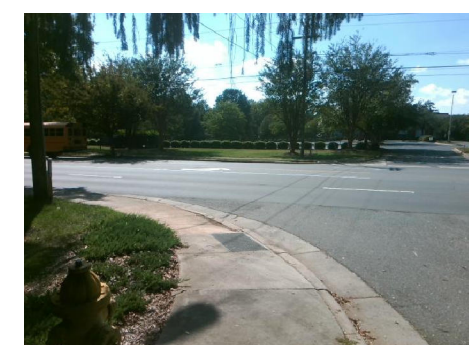
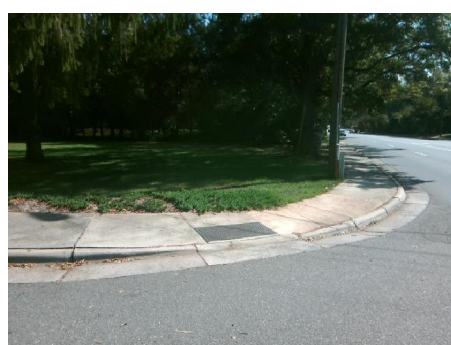
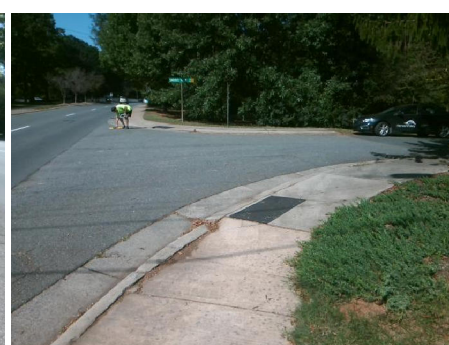
Not Found, R304.2.2, R304.5.3

Compliance	Description	Data	Compliance	Description	Data
N/A	Ramp Length (in)	59.0	No	Ramp Slope (%)	9.1
Yes	Ramp Width (in)	48.0	No	Ramp XSlope (%)	7.5
N/A	Flare Type LT	N/A	N/A	Flare Type RT	N/A
N/A	Flare Slope LT (%)	N/A	N/A	Flare Slope RT (%)	N/A
N/A	Flare Traversable LT?	N/A	N/A	Flare Traversable RT?	N/A
N/A	Landing Length (in)	N/A	N/A	DWS Provided?	N/A
N/A	Landing Width (in)	N/A	N/A	DWS Contrast?	N/A
N/A	Landing Slope (%)	N/A	N/A	DWS Length (in)	N/A
N/A	Landing X Slope (%)	N/A	N/A	DWS Full Width?	N/A
N/A	Landing Curb? (Y/N)	N/A	N/A	DWS Offset (in)	N/A
N/A	Shared Landing?	N/A			
N/A	Gutter Ponding?	N/A	N/A	Gutter Slope (%)	N/A
N/A	Gutter Lip Ht (in)	N/A	N/A	Gutter X Slope (%)	N/A
N/A	Painted X Walk1?	No	N/A	Painted X Walk2?	No
	X Walk 1 Direction	To N		X Walk 2 Direction	To W
N/A	X Walk 1 Width (in)	N/A	N/A	X Walk 2 Width (in)	N/A
	X Walk 1 Slope (%)	3.1		X Walk 2 Slope (%)	2.8
	X Walk 1 X Slope (%)	1.9		X Walk 2 X Slope (%)	4.2

N/A	Ramp inside XWalk1?	N/A	N/A	Ramp inside XWalk2?	N/A
	Road Slope (%)	2.9	N/A	Clear Space?	N/A
	Road X Slope (%)	3.6	N/A	Clear Space to XWalk (in)	N/A
N/A	Any Obstructions?	N/A	N/A	Storm Grate/Utility Hazard?	N/A
	Obstruction Type			Storm Grate/Utility Type	
		N/A			N/A
			Yes	Surface Condition? (G/P)	Good

Possible Solutions:

Remove & Replace Curb Ramp With Two New Directional Ramps or Equivalent.
