## Access Compliance Report Public Rights-of-Way (Curb Ramps)

Intersection ID: 50301 Main Street: WINGED\_TEAL\_RD Cross Street: PINE\_CHAPEL\_DR Location: SE

ADA ID: 06D32E40818F Ramp Type: BlendTrans1 Initial Pass/Fail: Fail Overall Compliance: No Severity Score: 8.75

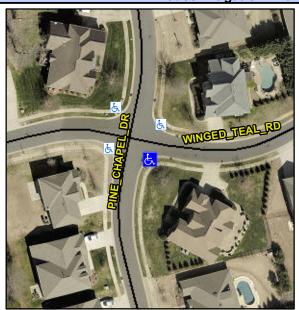
Not Found, R304.5.1

Compliance Description		Data	Compliance Description		Data
N/A	Ramp Length (in)	47.0	Yes	BlendTrans Slope (%)	2.5
No	Ramp Width (in)	47.0	Yes	BlendTrans XSlope (%)	0.5
N/A	Flare Type LT	N/A	N/A	Flare Type RT	N/A
N/A	Flare Slope LT (%)	N/A	N/A	Flare Slope RT (%)	N/A
N/A	Flare Traversable LT?	N/A	N/A	Flare Traversable RT?	N/A
N/A	Landing Length (in)	N/A	N/A	DWS Provided?	N/A
N/A	Landing Width (in)	N/A	N/A	DWS Contrast?	N/A
N/A	Landing Slope (%)	N/A	N/A	DWS Length (in)	N/A
N/A	Landing X Slope (%)	N/A	N/A	DWS Full Width?	N/A
N/A	Landing Curb? (Y/N)	N/A	N/A	DWS Offset (in)	N/A
N/A	Shared Landing?	N/A			
N/A	Gutter Ponding?	N/A	N/A	Gutter Slope (%)	N/A
N/A	Gutter Lip Ht (in)	N/A	N/A	Gutter X Slope (%)	N/A
N/A	Painted X Walk1?	No	N/A	Painted X Walk2?	No
	X Walk 1 Direction	To N		X Walk 2 Direction	To W
	X Walk 1 Width (in)	N/A		X Walk 2 Width (in)	N/A
	X Walk 1 Slope (%)	2.7		X Walk 2 Slope (%)	2.7
	X Walk 1 X Slope (%)	1.3		X Walk 2 X Slope (%)	2.9

Remove & Replace Curb Ramp With
Two New Directional Ramps or
Equivalent.
