Access Compliance Report

Public Rights-of-Way

(Curb Ramps)

Intersection ID: 16373	Main Street: MONROE RD	Cross Street: EATON RD	Location: NE
ADA ID: 06D5F4ECECB3	Ramp Type: PerpDiag	Initial Pass/Fail: Fail	Overall Compliance: No
Severity Score: 37.5			
Codes/Mitigation Info/Possible Solution		Field Measurements/Component Compliance

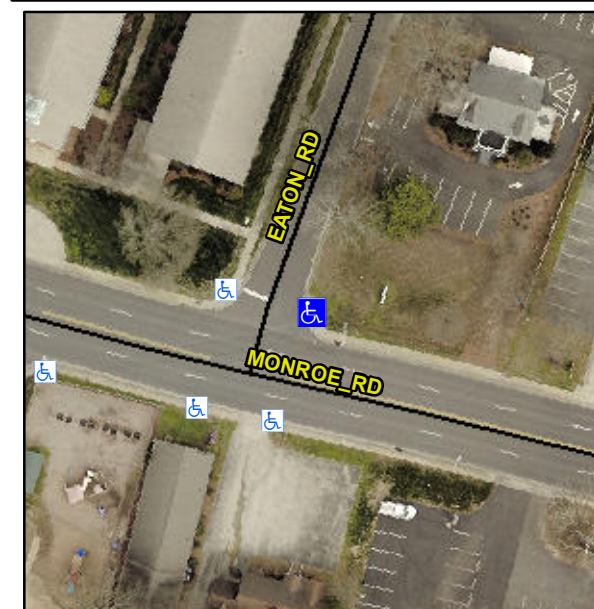
Not Found, R304.2.2, R304.5.3

Compliance	Description	Data	Compliance	Description	Data
N/A	Ramp Length (in)	49.0	No	Ramp Slope (%)	9.2
Yes	Ramp Width (in)	48.0	No	Ramp XSlope (%)	9.2
N/A	Flare Type LT	N/A	N/A	Flare Type RT	N/A
N/A	Flare Slope LT (%)	N/A	N/A	Flare Slope RT (%)	N/A
N/A	Flare Traversable LT?	N/A	N/A	Flare Traversable RT?	N/A
N/A	Landing Length (in)	N/A	N/A	DWS Provided?	N/A
N/A	Landing Width (in)	N/A	N/A	DWS Contrast?	N/A
N/A	Landing Slope (%)	N/A	N/A	DWS Length (in)	N/A
N/A	Landing X Slope (%)	N/A	N/A	DWS Full Width?	N/A
N/A	Landing Curb? (Y/N)	N/A	N/A	DWS Offset (in)	N/A
N/A	Shared Landing?	N/A			
N/A	Gutter Ponding?	N/A	N/A	Gutter Slope (%)	N/A
N/A	Gutter Lip Ht (in)	N/A	N/A	Gutter X Slope (%)	N/A
N/A	Painted X Walk1?	No	N/A	Painted X Walk2?	No
	X Walk 1 Direction	To NW		X Walk 2 Direction	To SW
N/A	X Walk 1 Width (in)	N/A	N/A	X Walk 2 Width (in)	N/A
	X Walk 1 Slope (%)	9.7		X Walk 2 Slope (%)	6.8
	X Walk 1 X Slope (%)	6.7		X Walk 2 X Slope (%)	2.3

N/A	Ramp inside XWalk1?	N/A	N/A	Ramp inside XWalk2?	N/A
	Road Slope (%)	6.0	N/A	Clear Space?	N/A
	Road X Slope (%)	4.5	N/A	Clear Space to XWalk (in)	N/A
N/A	Any Obstructions?	N/A	N/A	Storm Grate/Utility Hazard?	N/A
	Obstruction Type			Storm Grate/Utility Type	
		N/A			N/A
		Yes		Surface Condition? (G/P)	Good

Remove & Replace Curb Ramp With Two New Directional Ramps or Equivalent.
