Access Compliance Report

Public Rights-of-Way

(Curb Ramps)

Intersection ID: 8886	Main Street: LAKEWOOD_AV	Cross Street: ROZZELLES_FERRY_RD	Location: S
ADA ID: 06DB15EADD39	Ramp Type: PerpDiag	Initial Pass/Fail: Fail	Overall Compliance: No
Codes/Mitigation Info/Possible Solution		Field Measurements/Component Compliance	
Severity Score: 8.75

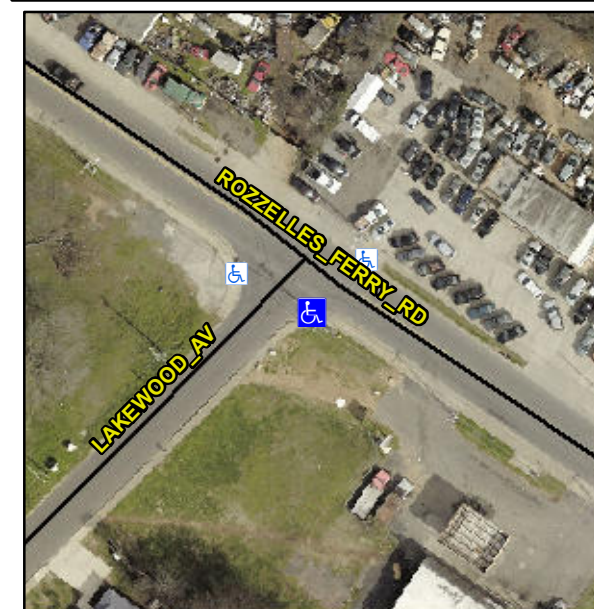
Not Found, R304.5.1

Compliance	Description	Data	Compliance	Description	Data
N/A	Ramp Length (in)	58.0	Yes	Ramp Slope (%)	7.5
No	Ramp Width (in)	43.0	Yes	Ramp XSlope (%)	1.1
N/A	Flare Type LT	N/A	N/A	Flare Type RT	N/A
N/A	Flare Slope LT (%)	N/A	N/A	Flare Slope RT (%)	N/A
N/A	Flare Traversable LT?	N/A	N/A	Flare Traversable RT?	N/A
N/A	Landing Length (in)	N/A	N/A	DWS Provided?	N/A
N/A	Landing Width (in)	N/A	N/A	DWS Contrast?	N/A
N/A	Landing Slope (%)	N/A	N/A	DWS Length (in)	N/A
N/A	Landing X Slope (%)	N/A	N/A	DWS Full Width?	N/A
N/A	Landing Curb? (Y/N)	N/A	N/A	DWS Offset (in)	N/A
N/A	Shared Landing?	N/A			
N/A	Gutter Ponding?	N/A	N/A	Gutter Slope (%)	N/A
N/A	Gutter Lip Ht (in)	N/A	N/A	Gutter X Slope (%)	N/A
N/A	Painted X Walk1?	No	N/A	Painted X Walk2?	No
	X Walk 1 Direction	To NE		X Walk 2 Direction	To NW
N/A	X Walk 1 Width (in)	N/A	N/A	X Walk 2 Width (in)	N/A
	X Walk 1 Slope (%)	5.3		X Walk 2 Slope (%)	3.6
	X Walk 1 X Slope (%)	1.5		X Walk 2 X Slope (%)	2.2

N/A	Ramp inside XWalk1?	N/A	N/A	Ramp inside XWalk2?	N/A
	Road Slope (%)	1.5	N/A	Clear Space?	N/A
	Road X Slope (%)	1.4	N/A	Clear Space to XWalk (in)	N/A
N/A	Any Obstructions?	N/A	N/A	Storm Grate/Utility Hazard?	N/A
	Obstruction Type			Storm Grate/Utility Type	
		N/A			N/A
			Yes	Surface Condition? (G/P)	Good

Remove & Replace Curb Ramp With Two New Directional Ramps or Equivalent.
