# Access Compliance Report

## Public Rights-of-Way

### (Curb Ramps)

| Intersection ID: 51618 | Main Street: SUMMERFORD_DR | Cross Street: PROSPERITY_CHURCH_RD | Location: NW |

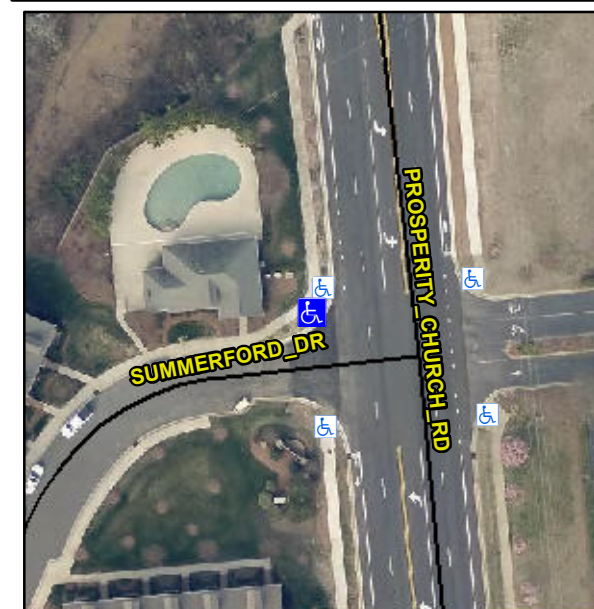
**Not Found, R304.5.3, R304.2.2-Perp, R304.3.2-Para, R305.2**

| Compliance | Description | Data | Compliance | Description | Data |
|---|---|---|---|---|---|
| Yes | Ramp Width (in) | 73.0 | No | BlendTrans XSlope (%) | 3.8 |
| No | Landing Slope (%) | 2.2 | Yes | DWS Length (in) | 24.5 |
| N/A | Landing Curb? (Y/N) | No | No | DWS Offset (in) | 7.0 |
| Yes | Gutter Lip Ht (in) | 0.0 | No | Gutter X Slope (%) | 2.3 |
| | | | No | Curb Slope (%) | 21.8 |

**Remove & Replace Curb Ramp With Two New Directional Ramps or Equivalent. Remove & Replace Gutter.**

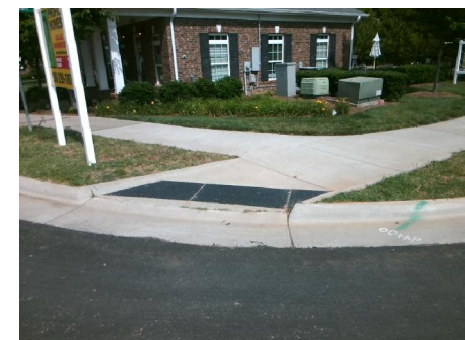
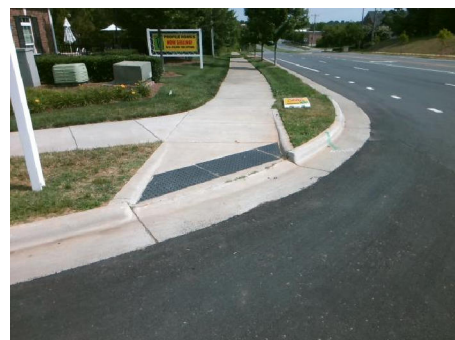
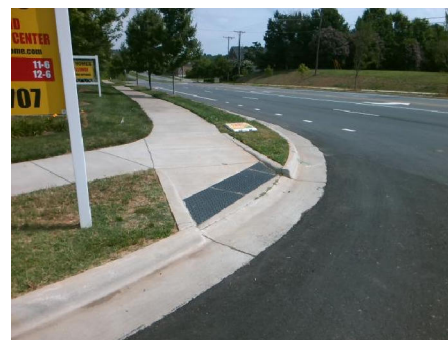
| ADA ID: 06E861E1AECA | Ramp Type: BlendTrans1 | Initial Pass/Fail: Pass | Overall Compliance: No |
| Severity Score: 0.25 | | | |
