# Access Compliance Report

## Public Rights-of-Way

### (Curb Ramps)

| Intersection ID: 11799 | Main Street: MECKLENBURG_AV | Cross Street: NORCROSS_PL | Location: NW |

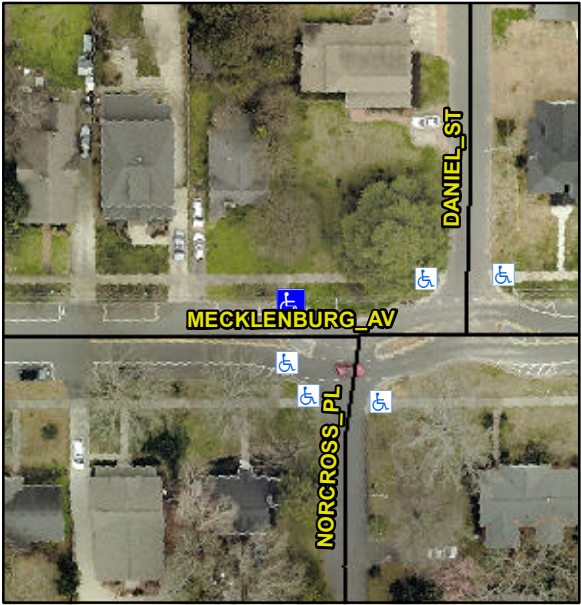
| Codes/Mitigation Info/Possible Solution | | | Field Measurements/Component Compliance | | |
|---|---|--|---|---|---|
| | | | <b>No</b> | Landing X Slope (%) | 3.0 |
| | | | <b>No</b> | Gutter Lip Ht (in) | 0.0 |

| Codes/Mitigation Info/Possible Solution | | | Field Measurements/Component Compliance | | |
|---|---|--|---|---|---|
| | <b>Remove &amp; Replace Landing.</b><br><b>Remove &amp; Replace Gutter.</b> | | <b>Compliance</b> | <b>Description</b> | <b>Data</b> |

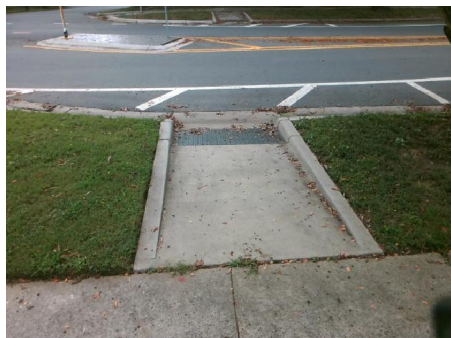
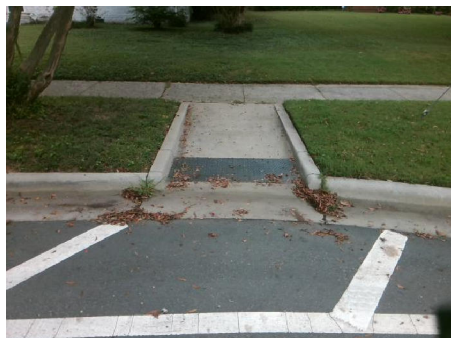
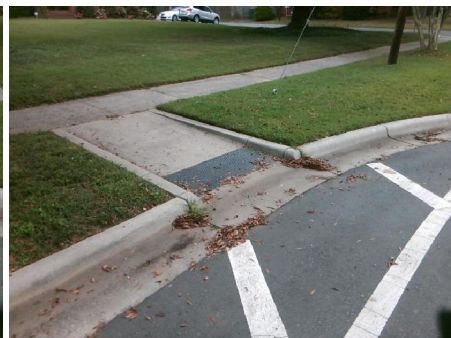
| ADA ID: 06F1FF36B805 | Ramp Type: Perp | Initial Pass/Fail: Pass | Overall Compliance: No |

| Codes/Mitigation Info/Possible Solution | | | Field Measurements/Component Compliance | | |
|---|---|--|---|---|---|
| | | | <b>No</b> | DWS Contrast? | Yes |
| | | | <b>No</b> | DWS Full Width? | Yes |
| | | | <b>No</b> | Gutter X Slope (%) | 3.3 |
