Access Compliance Report

Public Rights-of-Way

(Curb Ramps)

Intersection ID: 46805	Main Street: ARBOR_CREST_CT	Cross Street: RED_BIRCH_DR	Location: E
ADA ID: 06F59F4B66FF	Ramp Type: Perp	Initial Pass/Fail: Fail	Overall Compliance: No
Severity Score: 13.75			
Codes/Mitigation Info/Possible Solution		Field Measurements/Component Compliance

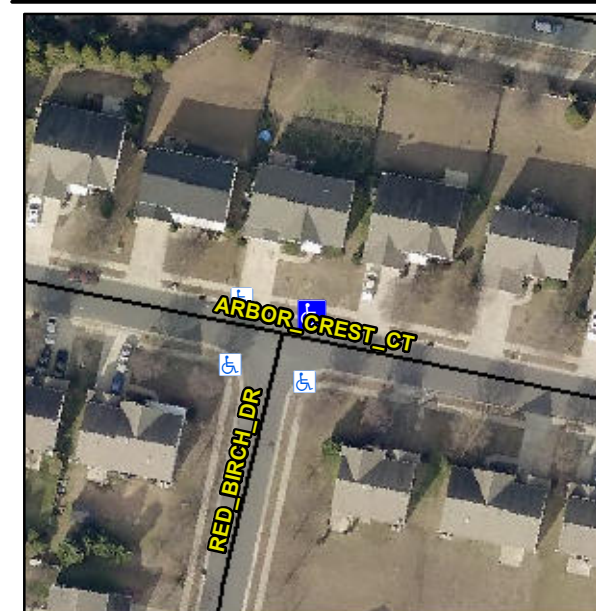
Not Found, R304.2.2

Compliance	Description	Data	Compliance	Description	Data
N/A	Ramp Length (in)	48.0	No	Ramp Slope (%)	8.4
Yes	Ramp Width (in)	52.0	Yes	Ramp XSlope (%)	2.6
N/A	Flare Type LT	N/A	N/A	Flare Type RT	N/A
N/A	Flare Slope LT (%)	N/A	N/A	Flare Slope RT (%)	N/A
N/A	Flare Traversable LT?	N/A	N/A	Flare Traversable RT?	N/A
N/A	Landing Length (in)	N/A	N/A	DWS Provided?	N/A
N/A	Landing Width (in)	N/A	N/A	DWS Contrast?	N/A
N/A	Landing Slope (%)	N/A	N/A	DWS Length (in)	N/A
N/A	Landing X Slope (%)	N/A	N/A	DWS Full Width?	N/A
N/A	Landing Curb? (Y/N)	N/A	N/A	DWS Offset (in)	N/A
N/A	Shared Landing?	N/A			
N/A	Gutter Ponding?	N/A	N/A	Gutter Slope (%)	N/A
N/A	Gutter Lip Ht (in)	N/A	N/A	Gutter X Slope (%)	N/A
N/A	Painted X Walk1?	No	N/A	Painted X Walk2?	N/A
	X Walk 1 Direction	To SW		X Walk 2 Direction	N/A
N/A	X Walk 1 Width (in)	N/A	N/A	X Walk 2 Width (in)	N/A
	X Walk 1 Slope (%)	3.2		X Walk 2 Slope (%)	N/A
	X Walk 1 X Slope (%)	3.1		X Walk 2 X Slope (%)	N/A

N/A	Ramp inside XWalk1?	N/A	N/A	Ramp inside XWalk2?	N/A
	Road Slope (%)	N/A	N/A	Clear Space?	N/A
	Road X Slope (%)	N/A	N/A	Clear Space to XWalk (in)	N/A
N/A	Any Obstructions?	N/A	N/A	Storm Grate/Utility Hazard?	N/A
	Obstruction Type			Storm Grate/Utility Type	
		N/A			N/A
			Yes	Surface Condition? (G/P)	Good

Possible Solutions:

Remove & Replace Entire Ramp.

Total Cost: \$ 1850.00
