## **Access Compliance Report Public Rights-of-Way** (Curb Ramps)

Intersection ID: 10041415 Main Street: WESTHALL\_DR Cross Street: N/A Location: ADA ID: 06F994AB917A Ramp Type: PerpDiag Initial Pass/Fail: Fail **Overall Compliance: No** Severity Score: 21.25

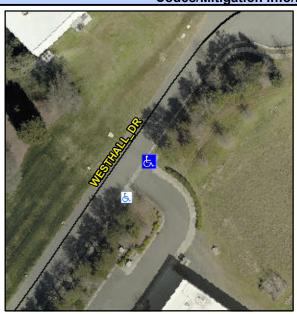
Field Measurements/Component Compliance							
Compliance Description		Data	Comp	liance	Description	Data	
N/A	Ramp Length (in)	77.0	Yes	Ram	Slope (%)	6.4	
No	Ramp Width (in)	47.5	No	Ram	XSlope (%)	5.9	
N/A	Flare Type LT	N/A	N/A	Flare	Type RT	N/A	
N/A	Flare Slope LT (%)	N/A	N/A	Flare	Slope RT (%)	N/A	
N/A	Flare Traversable LT?	N/A	N/A	Flare	Traversable RT?	N/A	
N/A	Landing Length (in)	N/A	N/A	DWS	Provided?	N/A	
N/A	Landing Width (in)	N/A	N/A	DWS	Contrast?	N/A	
N/A	Landing Slope (%)	N/A	N/A	DWS	Length (in)	N/A	
N/A	Landing X Slope (%)	N/A	N/A	DWS	Full Width?	N/A	
N/A	Landing Curb? (Y/N)	N/A	N/A	DWS	Offset (in)	N/A	
N/A	Shared Landing?	N/A					
N/A	Gutter Ponding?	N/A	N/A	Gutte	er Slope (%)	N/A	
N/A	Gutter Lip Ht (in)	N/A	N/A	Gutte	r X Slope (%)	N/A	
N/A	Painted X Walk1?	No	N/A	Paint	ed X Walk2?	No	
	X Walk 1 Direction	To NW		X Wa	lk 2 Direction	To SW	
N/A	X Walk 1 Width (in)	N/A	N/A	X Wa	lk 2 Width (in)	N/A

X Walk 1 Slope (%)	0.6		X Wa	lk 2 Slope (%)	1.6	
	X Walk 1 X Slope (%)	2.7		X Wa	lk 2 X Slope (%)	2.9	
N/A	Ramp inside XWalk1?	N/A	N/A	Ram	inside XWalk2?	N/A	
	Road Slope (%)	4.1	N/A	Clear	Space?	N/A	
	Road X Slope (%)	0.9	N/A	Clear	Space to XWalk (in)	N/A	
N/A	Any Obstructions?	N/A	N/A	Storn	n Grate/Utility Hazard?	N/A	
	Obstruction Type			Storn	n Grate/Utility Type		
		N/A				N/A

Possible Solutions:
Remove & Replace Curb Ramp With Two New Directional Ramps or Equivalent.
Surveyor Notes: N/A
PROW/ADA: Not Found, R304.5.1, R304.5.3
