Access Compliance Report

Public Rights-of-Way

(Curb Ramps)

Intersection ID: 10012605	Main Street: MEADOW_KNOLL_DR	Cross Street: N/A	Location: E
ADA ID: 06FDCBE03DA9	Ramp Type: PerpDiag	Initial Pass/Fail: Fail	Overall Compliance: No
		Severity Score: 8.75

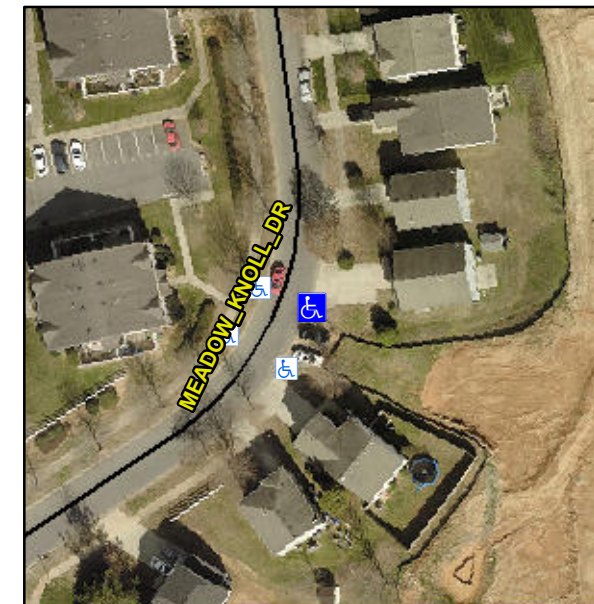
Compliance	Description	Data	Compliance	Description	Data
N/A	Ramp Length (in)	87.0	Yes	Ramp Slope (%)	6.1
No	Ramp Width (in)	46.0	Yes	Ramp XSlope (%)	2.0
N/A	Flare Type LT	N/A	N/A	Flare Type RT	N/A
N/A	Flare Slope LT (%)	N/A	N/A	Flare Slope RT (%)	N/A
N/A	Flare Traversable LT?	N/A	N/A	Flare Traversable RT?	N/A
N/A	Landing Length (in)	N/A	N/A	DWS Provided?	N/A
N/A	Landing Width (in)	N/A	N/A	DWS Contrast?	N/A
N/A	Landing Slope (%)	N/A	N/A	DWS Length (in)	N/A
N/A	Landing X Slope (%)	N/A	N/A	DWS Full Width?	N/A
N/A	Landing Curb? (Y/N)	N/A	N/A	DWS Offset (in)	N/A
N/A	Shared Landing?	N/A			
N/A	Gutter Ponding?	N/A	N/A	Gutter Slope (%)	N/A
N/A	Gutter Lip Ht (in)	N/A	N/A	Gutter X Slope (%)	N/A
N/A	Painted X Walk1?	No	N/A	Painted X Walk2?	No
	X Walk 1 Direction	To NW		X Walk 2 Direction	To SW
N/A	X Walk 1 Width (in)	N/A	N/A	X Walk 2 Width (in)	N/A
	X Walk 1 Slope (%)	2.5		X Walk 2 Slope (%)	3.0
	X Walk 1 X Slope (%)	0.0		X Walk 2 X Slope (%)	0.2

N/A	Ramp inside XWalk1?	N/A	N/A	Ramp inside XWalk2?	N/A
	Road Slope (%)	3.3	N/A	Clear Space?	N/A
	Road X Slope (%)	3.5	N/A	Clear Space to XWalk (in)	N/A
N/A	Any Obstructions?	N/A	N/A	Storm Grate/Utility Hazard?	N/A
	Obstruction Type			Storm Grate/Utility Type	
		N/A			N/A
			Yes	Surface Condition? (G/P)	Good

Remove & Replace Curb Ramp With Two New Directional Ramps or Equivalent.
