Access Compliance Report

Public Rights-of-Way (Curb Ramps)

| Intersection ID: 48556 | Main Street: COTTON_PRESS_RD | Cross Street: BRANCHWATER_AV | Location: NW |
| ADA ID: 07014410D660 | Ramp Type: Perp | Initial Pass/Fail: Fail | Overall Compliance: No |

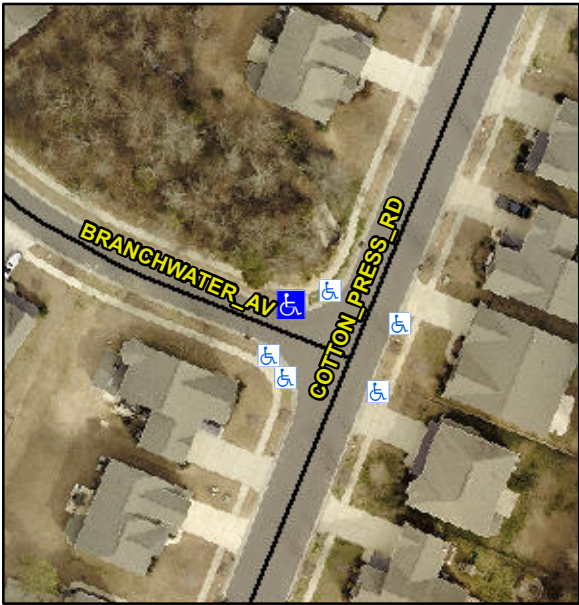
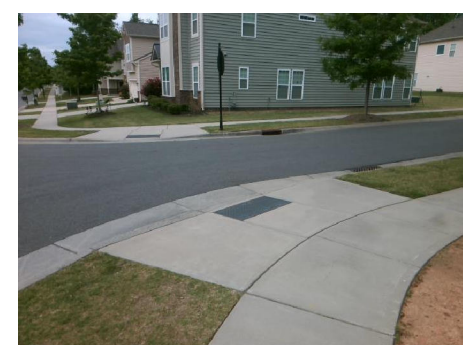
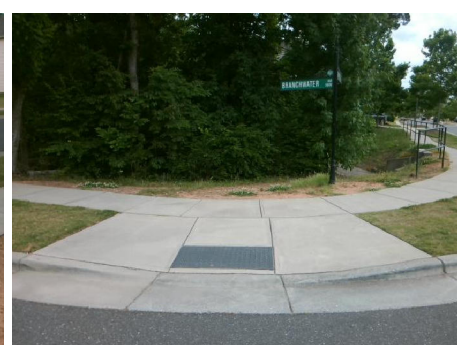
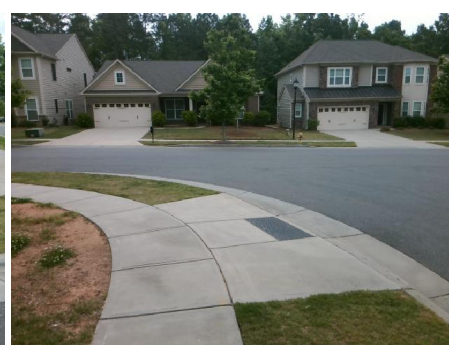
| | | Severity Score: 8.75 | |

| Codes/Mitigation Info/Possible Solution | | | Field Measurements/Component Compliance | | | | | |
|--|---|---|---|---|---|---|---|---|
| | | | No | Ramp Width (in) | 47.0 | Yes | Ramp XSlope (%) | 0.4 |
| PROW/ADA: | | Not Found, R304.5.1 | N/A | Shared Landing? | N/A | | | |

| Codes/Mitigation Info/Possible Solution | | | Field Measurements/Component Compliance | | | | | |
|--|---|---|---|---|---|---|---|---|
| | Remove & Replace Entire Ramp. | | N/A | Ramp Length (in) | 73.0 | Yes | Ramp Slope (%) | 8.3 |
| Total Cost: | | \$ 1850.00 | | | | | | |
