Access Compliance Report

Public Rights-of-Way

(Curb Ramps)

Intersection ID: 10020011	Main Street: ARROWPOINT_BV	Cross Street: N/A	Location: W
ADA ID: 070685F63B22	Ramp Type: Perp	Initial Pass/Fail: Fail	Overall Compliance: No
Codes/Mitigation Info/Possible Solution		Field Measurements/Component Compliance	
Severity Score: 33.75

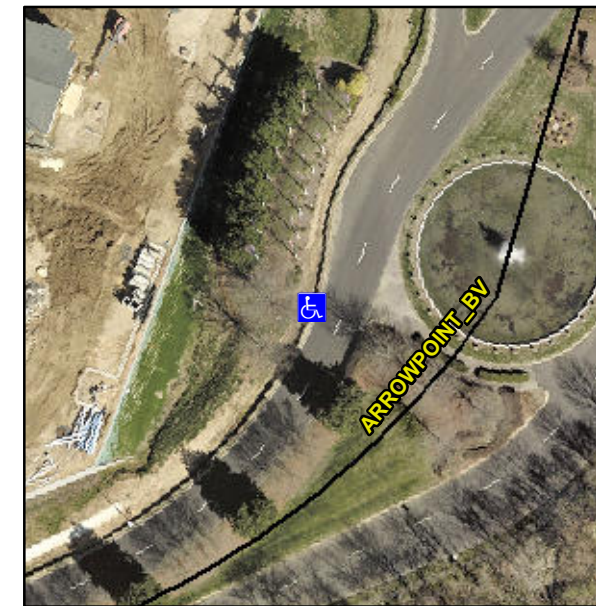
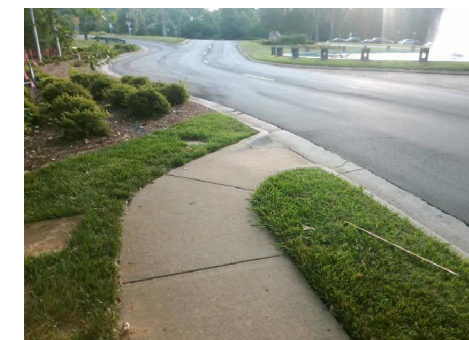
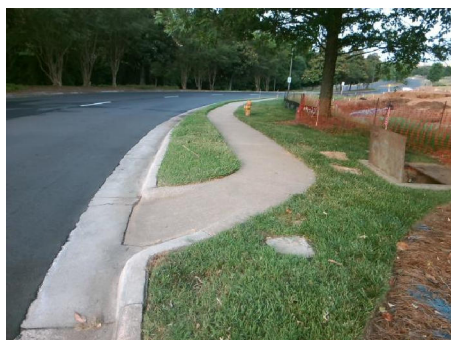
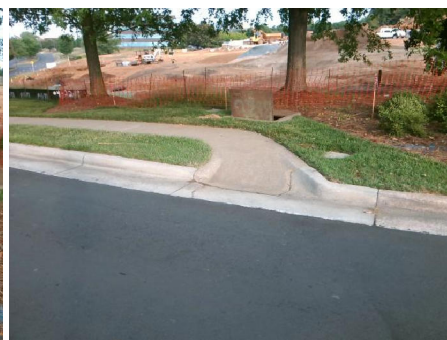
Not Found, R304.5.1, R304.2.2

Compliance	Description	Data	Compliance	Description	Data
N/A	Ramp Length (in)	54.0	No	Ramp Slope (%)	14.1
No	Ramp Width (in)	41.0	Yes	Ramp XSlope (%)	1.6
N/A	Flare Type LT	N/A	N/A	Flare Type RT	N/A
N/A	Flare Slope LT (%)	N/A	N/A	Flare Slope RT (%)	N/A
N/A	Flare Traversable LT?	N/A	N/A	Flare Traversable RT?	N/A
N/A	Landing Length (in)	N/A	N/A	DWS Provided?	N/A
N/A	Landing Width (in)	N/A	N/A	DWS Contrast?	N/A
N/A	Landing Slope (%)	N/A	N/A	DWS Length (in)	N/A
N/A	Landing X Slope (%)	N/A	N/A	DWS Full Width?	N/A
N/A	Landing Curb? (Y/N)	N/A	N/A	DWS Offset (in)	N/A
N/A	Shared Landing?	N/A			
N/A	Gutter Ponding?	N/A	N/A	Gutter Slope (%)	N/A
N/A	Gutter Lip Ht (in)	N/A	N/A	Gutter X Slope (%)	N/A
N/A	Painted X Walk1?	No	N/A	Painted X Walk2?	N/A
	X Walk 1 Direction	To E		X Walk 2 Direction	N/A
N/A	X Walk 1 Width (in)	N/A	N/A	X Walk 2 Width (in)	N/A
	X Walk 1 Slope (%)	5.1		X Walk 2 Slope (%)	N/A
	X Walk 1 X Slope (%)	2.0		X Walk 2 X Slope (%)	N/A

N/A	Ramp inside XWalk1?	N/A	N/A	Ramp inside XWalk2?	N/A
	Road Slope (%)	N/A	N/A	Clear Space?	N/A
	Road X Slope (%)	N/A	N/A	Clear Space to XWalk (in)	N/A
N/A	Any Obstructions?	N/A	N/A	Storm Grate/Utility Hazard?	N/A
	Obstruction Type			Storm Grate/Utility Type	
		N/A			N/A
			Yes	Surface Condition? (G/P)	Good

Possible Solutions:

Remove & Replace Entire Ramp.

Total Cost: \$ 1850.00
