Access Compliance Report

Public Rights-of-Way

(Curb Ramps)

Intersection ID: 9476	Main Street: CHANNING_CT	Cross Street: RUPERT_LN	Location: S
ADA ID: 070785CACF08	Ramp Type: Perp	Initial Pass/Fail: Fail	Overall Compliance: No
			Severity Score: 26.25

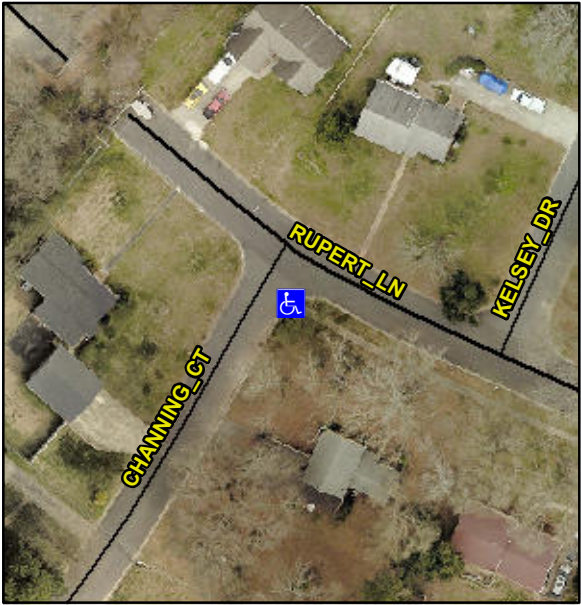
Possible Solutions:		Compliance	Description	Data
	Remove & Replace Entire Ramp.		No	Ramp Length (in)	25.0
			Yes	Ramp Width (in)	48.0
			N/A	Flare Type LT	N/A
			N/A	Flare Slope LT (%)	N/A
			N/A	Flare Traversable LT?	N/A
			N/A	Landing Length (in)	N/A
			N/A	Landing Width (in)	N/A
			N/A	Landing Slope (%)	N/A
			N/A	Landing X Slope (%)	N/A
<p>Surveyor Notes:</p> <p>N/A</p> <p>PROW/ADA:</p> <p>Not Found, R304.2.2, R304.5.3</p>			N/A	Flare Type RT	N/A
			N/A	Flare Slope RT (%)	N/A
			N/A	Flare Traversable RT?	N/A
			N/A	DWS Provided?	N/A
			N/A	DWS Contrast?	N/A
			N/A	DWS Length (in)	N/A
			N/A	DWS Full Width?	N/A
			N/A	DWS Offset (in)	N/A
			N/A	Shared Landing?	N/A
			N/A	Gutter Ponding?	N/A
			N/A	Gutter Lip Ht (in)	1.0
			N/A	Painted X Walk1?	No
				X Walk 1 Direction	To NE
			N/A	X Walk 1 Width (in)	N/A
				X Walk 1 Slope (%)	0.1

X Walk 1 X Slope (%)	1.5
			N/A	Ramp inside XWalk1?	N/A
			N/A	Ramp inside XWalk2?	N/A
			N/A	Road Slope (%)	N/A
			N/A	Road X Slope (%)	N/A
			N/A	Any Obstructions?	N/A
				Obstruction Type	
			N/A		
			N/A		
			N/A		
			N/A		
			N/A		
			N/A		
			N/A		
			N/A		
			Yes	Surface Condition? (G/P)	Good
