Access Compliance Report

Public Rights-of-Way

(Curb Ramps)

Intersection ID: 11597	Main Street: E_20TH_ST	Cross Street: SEIGLE_AV	Location: SE
ADA ID: 0707F4CFBF08	Ramp Type: Para	Initial Pass/Fail: Fail	Overall Compliance: No
Severity Score: 12.5			
Codes/Mitigation Info/Possible Solution		Field Measurements/Component Compliance

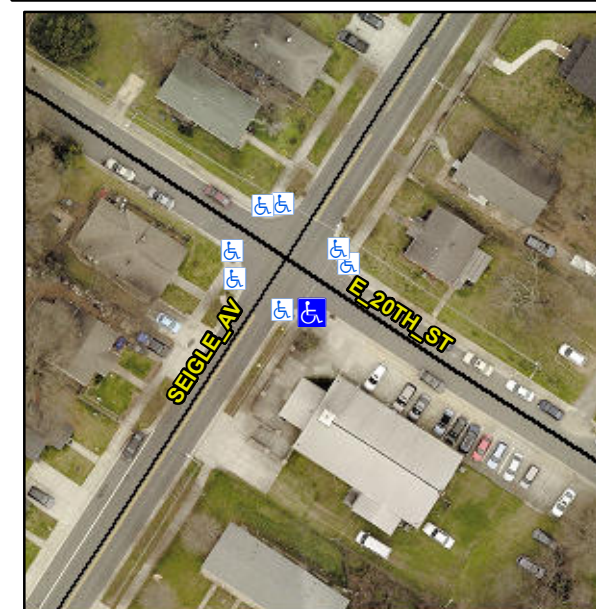
Compliance	Description	Data	Compliance	Description	Data
N/A	Ramp Length LT (in)	54.0	N/A	Ramp Length RT (in)	N/A
Yes	Ramp Width LT (in)	50.5	N/A	Ramp Width RT (in)	N/A
No	Ramp Slope LT (%)	8.4	N/A	Ramp Slope RT (%)	N/A
Yes	Ramp XSlope LT (%)	2.0	N/A	Ramp XSlope RT (%)	N/A
N/A	Landing Length (in)	N/A	N/A	DWS Provided?	N/A
N/A	Landing Width (in)	N/A	N/A	DWS Contrast?	N/A
N/A	Landing Slope (%)	N/A	N/A	DWS Length (in)	N/A
N/A	Landing X Slope (%)	N/A	N/A	DWS Full Width?	N/A
N/A	Landing Curb? (Y/N)	N/A	N/A	DWS Offset (in)	N/A
N/A	Shared Landing?	N/A			
N/A	Gutter Ponding?	N/A	N/A	Gutter Slope (%)	N/A
N/A	Gutter Lip Ht (in)	0.5	N/A	Gutter X Slope (%)	N/A
N/A	Painted X Walk1?	No	N/A	Painted X Walk2?	N/A
	X Walk 1 Direction	To NE		X Walk 2 Direction	N/A
N/A	X Walk 1 Width (in)	N/A	N/A	X Walk 2 Width (in)	N/A
	X Walk 1 Slope (%)	7.3		X Walk 2 Slope (%)	N/A
	X Walk 1 X Slope (%)	0.4		X Walk 2 X Slope (%)	N/A
N/A	Ramp inside XWalk1?	N/A	N/A	Ramp inside XWalk2?	N/A

Road Slope (%)	N/A	N/A	Clear Space?	N/A
	Road X Slope (%)	N/A	N/A	Clear Space to XWalk (in)	N/A
N/A	Any Obstructions?	N/A	N/A	Storm Grate/Utility Hazard?	N/A
	Obstruction Type			Storm Grate/Utility Type	
		N/A			N/A
			Yes	Surface Condition? (G/P)	Good
			N/A	Curb Slope (%)	6.6

Possible Solutions:

Remove & Replace Entire Ramp.

R304.3.2

\$ 1600.00
