Intersection ID: 50630	Main Street: TOM_SHORT_RD	Cross Street: CORAL_ROSE_RD	Location:	SW
ADA ID: 0725B6676494	Ramp Type: BlendTrans1	Initial Pass/Fail: Fail	Overall Compliance: No	Severity Score: 21.25

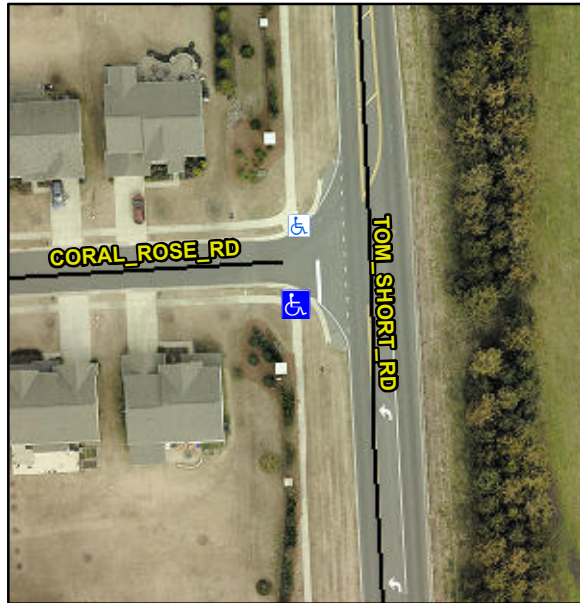
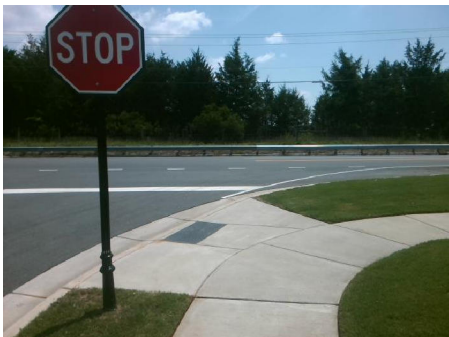
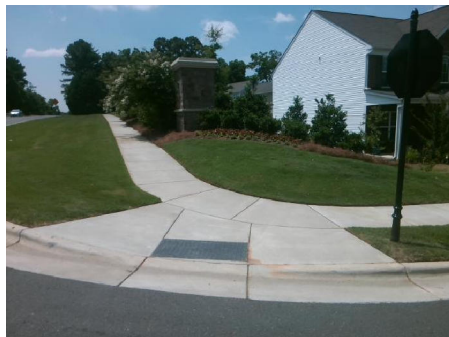
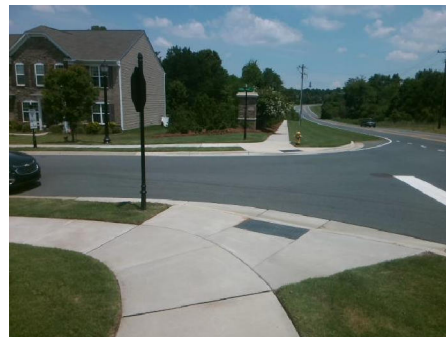
Compliance	Description	Data	Compliance	Description	Data
N/A	Ramp Length (in)	58.0	Yes	BlendTrans Slope (%)	2.1
No	Ramp Width (in)	47.0	No	BlendTrans XSlope (%)	5.1
N/A	Flare Type LT	N/A	N/A	Flare Type RT	N/A
N/A	Flare Slope LT (%)	N/A	N/A	Flare Slope RT (%)	N/A
N/A	Flare Traversable LT?	N/A	N/A	Flare Traversable RT?	N/A
N/A	Landing Length (in)	N/A	N/A	DWS Provided?	N/A
N/A	Landing Width (in)	N/A	N/A	DWS Contrast?	N/A
N/A	Landing Slope (%)	N/A	N/A	DWS Length (in)	N/A
N/A	Landing X Slope (%)	N/A	N/A	DWS Full Width?	N/A
N/A	Landing Curb? (Y/N)	N/A	N/A	DWS Offset (in)	N/A
N/A	Shared Landing?	N/A			
N/A	Gutter Ponding?	N/A	N/A	Gutter Slope (%)	N/A
N/A	Gutter Lip Ht (in)	N/A	N/A	Gutter X Slope (%)	N/A
N/A	Painted X Walk1?	No	N/A	Painted X Walk2?	No
	X Walk 1 Direction	To E		X Walk 2 Direction	To N
	X Walk 1 Width (in)	N/A		X Walk 2 Width (in)	N/A
	X Walk 1 Slope (%)	4.1		X Walk 2 Slope (%)	2.7
	X Walk 1 X Slope (%)	3.1		X Walk 2 X Slope (%)	6.9

N/A	Ramp inside XWalk1?	N/A	N/A	Ramp inside XWalk2?	N/A
	Road Slope (%)	6.1		Clear Space?	N/A
	Road X Slope (%)	0.1	N/A	Clear Space to XWalk (in)	N/A
N/A	Any Obstructions?	N/A	N/A	Storm Grate/Utility Hazard?	N/A
	Obstruction Type			Storm Grate/Utility Type	
		N/A			N/A
			Yes	Surface Condition? (G/P)	Good
			No	Curb Slope (%)	20.9

Remove & Replace Curb Ramp With Two New Directional Ramps or Equivalent.
