# Access Compliance Report

## Public Rights-of-Way

### (Curb Ramps)

Intersection ID: 27680	Main Street: LANCASTER_HY	Cross Street: BALLANTYNE_COMMONS_PY	Location: NE
ADA ID: 07262D48832B	Ramp Type: Perp	Initial Pass/Fail: Fail	Overall Compliance: No
Severity Score: 8.75			
Codes/Mitigation Info/Possible Solution		Field Measurements/Component Compliance

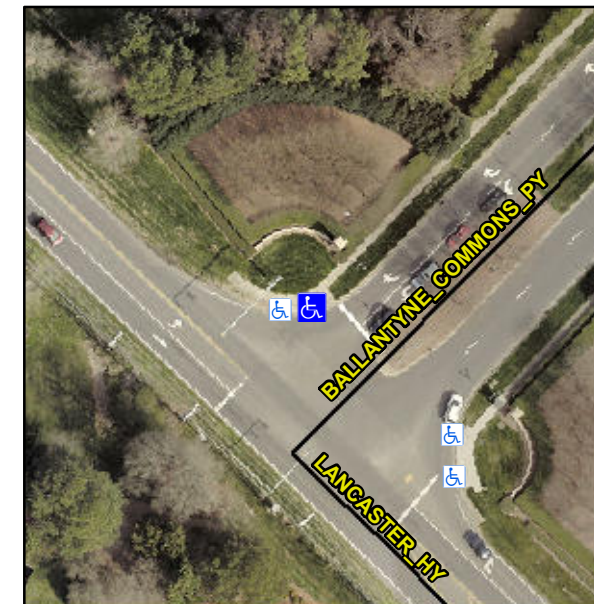
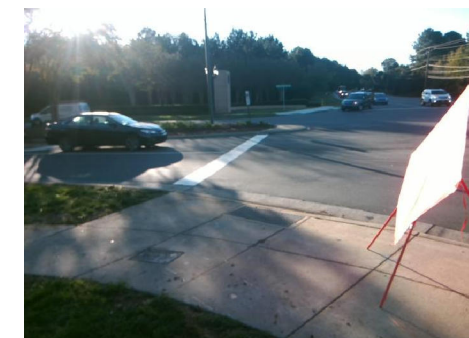
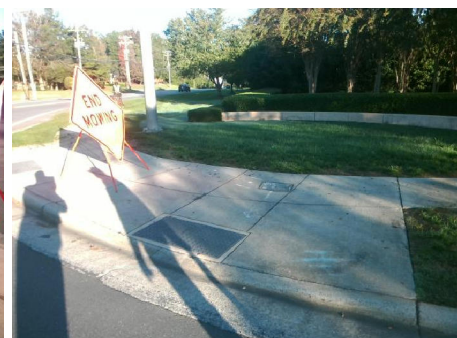
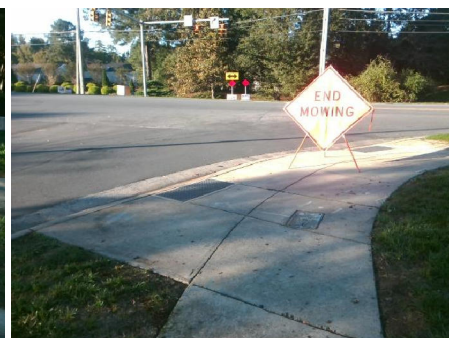
**Not Found, R304.5.1**

Compliance	Description	Data	Compliance	Description	Data
N/A	Ramp Length (in)	62.0	Yes	Ramp Slope (%)	5.1
No	Ramp Width (in)	45.0	Yes	Ramp XSlope (%)	1.0
N/A	Flare Type LT	N/A	N/A	Flare Type RT	N/A
N/A	Flare Slope LT (%)	N/A	N/A	Flare Slope RT (%)	N/A
N/A	Flare Traversable LT?	N/A	N/A	Flare Traversable RT?	N/A
N/A	Landing Length (in)	N/A	N/A	DWS Provided?	N/A
N/A	Landing Width (in)	N/A	N/A	DWS Contrast?	N/A
N/A	Landing Slope (%)	N/A	N/A	DWS Length (in)	N/A
N/A	Landing X Slope (%)	N/A	N/A	DWS Full Width?	N/A
N/A	Landing Curb? (Y/N)	N/A	N/A	DWS Offset (in)	N/A
N/A	Shared Landing?	N/A			
N/A	Gutter Ponding?	N/A	N/A	Gutter Slope (%)	N/A
N/A	Gutter Lip Ht (in)	N/A	N/A	Gutter X Slope (%)	N/A
N/A	Painted X Walk1?	No	N/A	Painted X Walk2?	N/A
	X Walk 1 Direction	To SE		X Walk 2 Direction	N/A
N/A	X Walk 1 Width (in)	N/A	N/A	X Walk 2 Width (in)	N/A
	X Walk 1 Slope (%)	0.2		X Walk 2 Slope (%)	N/A
	X Walk 1 X Slope (%)	3.1		X Walk 2 X Slope (%)	N/A

N/A	Ramp inside XWalk1?	N/A	N/A	Ramp inside XWalk2?	N/A
	Road Slope (%)	N/A	N/A	Clear Space?	N/A
	Road X Slope (%)	N/A	N/A	Clear Space to XWalk (in)	N/A
N/A	Any Obstructions?	N/A	N/A	Storm Grate/Utility Hazard?	N/A
	Obstruction Type			Storm Grate/Utility Type	
		N/A			N/A
			Yes	Surface Condition? (G/P)	Good

**Remove & Replace Entire Ramp.**

Total Cost: \$ 1850.00
