Access Compliance Report Public Rights-of-Way (Curb Ramps)

Intersection ID: 48459 Main Street: TARPWAY_RD Cross Street: QUINN_DR Location: W **ADA ID: 072706FCBC5F** Ramp Type: Perp Initial Pass/Fail: Fail **Overall Compliance: No Severity Score:** 10

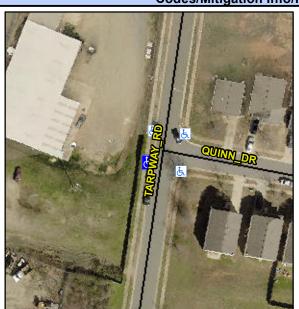
Field Measurements/Component Compliance								
Comp	liance Description	Data	Comp	liance	Description	Data		
N/A	Ramp Length (in)	48.0	Yes	Ram	Slope (%)	6.2		
No	Ramp Width (in)	47.0	Yes	Ram	XSlope (%)	2.9		
N/A	Flare Type LT	N/A	N/A	Flare	Type RT	N/A		
N/A	Flare Slope LT (%)	N/A	N/A	Flare	Slope RT (%)	N/A		
N/A	Flare Traversable LT?	N/A	N/A	Flare	Traversable RT?	N/A		
N/A	Landing Length (in)	N/A	N/A	DWS	Provided?	N/A		
N/A	Landing Width (in)	N/A	N/A	DWS	Contrast?	N/A		
N/A	Landing Slope (%)	N/A	N/A	DWS	Length (in)	N/A		
N/A	Landing X Slope (%)	N/A	N/A	DWS	Full Width?	N/A		
N/A	Landing Curb? (Y/N)	N/A	N/A	DWS	Offset (in)	N/A		
N/A	Shared Landing?	N/A						
N/A	Gutter Ponding?	N/A	N/A	Gutte	er Slope (%)	N/A		
N/A	Gutter Lip Ht (in)	N/A	N/A	Gutte	er X Slope (%)	N/A		
N/A	Painted X Walk1?	No	N/A	Paint	ed X Walk2?	N/A		
	X Walk 1 Direction	To SE		X Wa	lk 2 Direction	N/A		
N/A	X Walk 1 Width (in)	N/A	N/A	X Wa	ılk 2 Width (in)	N/A

X Walk 1 Slope (%)	3.7		X Wa	lk 2 Slope (%)	N/A		
	X Walk 1 X Slope (%)	3.1		X Wa	lk 2 X Slope (%)	N/A		
N/A	Ramp inside XWalk1?	N/A	N/A	Ram	o inside XWalk2?	N/A		
	Road Slope (%)	N/A	N/A	Clear	Space?	N/A		
	Road X Slope (%)	N/A	N/A	Clear	Space to XWalk (in)	N/A		
N/A	Any Obstructions?	N/A	N/A	Storn	n Grate/Utility Hazard?	N/A		
	Obstruction Type			Storn	n Grate/Utility Type			
		N/A				N/A		
			Yes	Surfa	ce Condition? (G/P)	Good

Possible Solutions:	9	
Remove & Replace Entire Ramp.		
	N	
	N	
	1	
	N	
	1	
Surveyor Notes:	1	
N/A	1	
	N	
	1	
	1	
PROW/ADA:	1	
Not Found, R304.5.1	N	
	ľ	
	N
