Access Compliance Report

Public Rights-of-Way

(Curb Ramps)

Intersection ID: 16075	Main Street: BUDDING_CT	Cross Street: ROSEMEDE_DR	Location: NW
ADA ID: 072825428354	Ramp Type: PerpDiag	Initial Pass/Fail: Fail	Overall Compliance: No
		Severity Score: 10

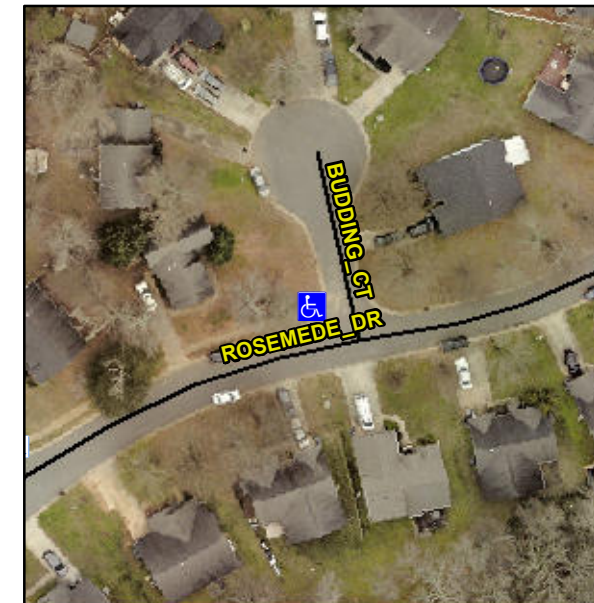
Not Found, R304.5.1, R304.5.3

Compliance	Description	Data	Compliance	Description	Data
N/A	Ramp Length (in)	48.0	Yes	Ramp Slope (%)	5.5
No	Ramp Width (in)	47.0	No	Ramp XSlope (%)	4.3
N/A	Flare Type LT	N/A	N/A	Flare Type RT	N/A
N/A	Flare Slope LT (%)	N/A	N/A	Flare Slope RT (%)	N/A
N/A	Flare Traversable LT?	N/A	N/A	Flare Traversable RT?	N/A
N/A	Landing Length (in)	N/A	N/A	DWS Provided?	N/A
N/A	Landing Width (in)	N/A	N/A	DWS Contrast?	N/A
N/A	Landing Slope (%)	N/A	N/A	DWS Length (in)	N/A
N/A	Landing X Slope (%)	N/A	N/A	DWS Full Width?	N/A
N/A	Landing Curb? (Y/N)	N/A	N/A	DWS Offset (in)	N/A
N/A	Shared Landing?	N/A			
N/A	Gutter Ponding?	N/A	N/A	Gutter Slope (%)	N/A
N/A	Gutter Lip Ht (in)	N/A	N/A	Gutter X Slope (%)	N/A
N/A	Painted X Walk1?	No	N/A	Painted X Walk2?	No
	X Walk 1 Direction	To E		X Walk 2 Direction	To S
N/A	X Walk 1 Width (in)	N/A	N/A	X Walk 2 Width (in)	N/A
	X Walk 1 Slope (%)	4.0		X Walk 2 Slope (%)	3.0
	X Walk 1 X Slope (%)	4.4		X Walk 2 X Slope (%)	2.1

N/A	Ramp inside XWalk1?	N/A	N/A	Ramp inside XWalk2?	N/A
	Road Slope (%)	4.4	N/A	Clear Space?	N/A
	Road X Slope (%)	2.1	N/A	Clear Space to XWalk (in)	N/A
N/A	Any Obstructions?	N/A	N/A	Storm Grate/Utility Hazard?	N/A
	Obstruction Type			Storm Grate/Utility Type	
		N/A			N/A
		Yes		Surface Condition? (G/P)	Good

Possible Solutions:

Remove & Replace Curb Ramp With Two New Directional Ramps or Equivalent.
