# Access Compliance Report

## Public Rights-of-Way

### (Curb Ramps)

Intersection ID: 48587	Main Street: STONEY_CREEK_LN	Cross Street: UNIVERSITY_CITY_BV	Location: NE
ADA ID: 072D1AC50C6F	Ramp Type: BlendTrans1	Initial Pass/Fail: Fail	Overall Compliance: No
Severity Score: 8.75			
Codes/Mitigation Info/Possible Solution		Field Measurements/Component Compliance

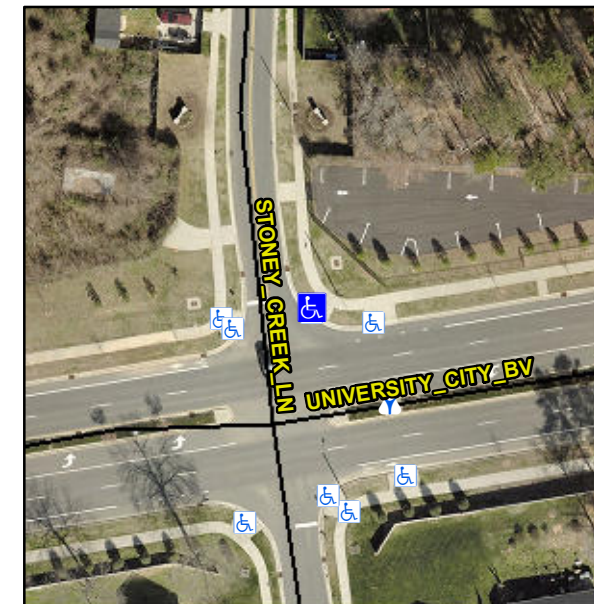
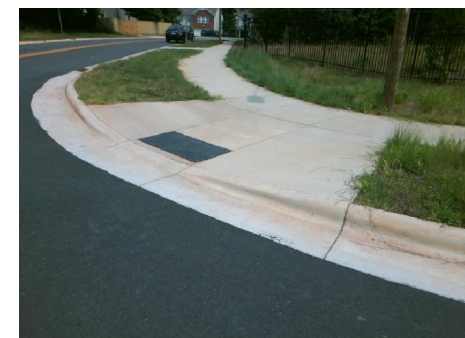
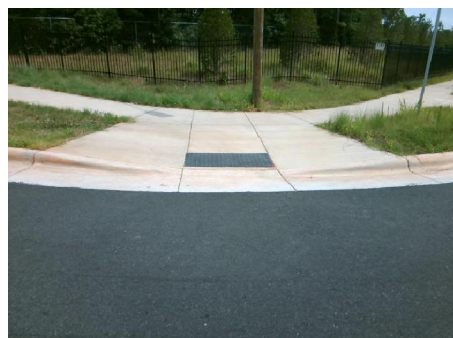
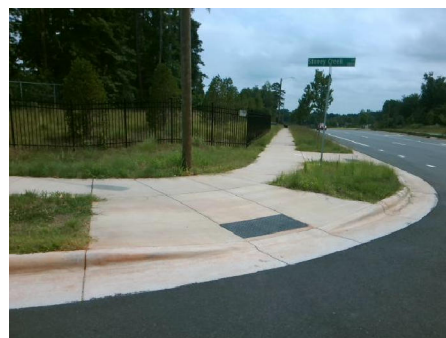
**Not Found, R304.5.1**

Compliance	Description	Data	Compliance	Description	Data
N/A	Ramp Length (in)	96.5	Yes	BlendTrans Slope (%)	3.5
No	Ramp Width (in)	47.5	Yes	BlendTrans XSlope (%)	0.7
N/A	Flare Type LT	N/A	N/A	Flare Type RT	N/A
N/A	Flare Slope LT (%)	N/A	N/A	Flare Slope RT (%)	N/A
N/A	Flare Traversable LT?	N/A	N/A	Flare Traversable RT?	N/A
N/A	Landing Length (in)	N/A	N/A	DWS Provided?	N/A
N/A	Landing Width (in)	N/A	N/A	DWS Contrast?	N/A
N/A	Landing Slope (%)	N/A	N/A	DWS Length (in)	N/A
N/A	Landing X Slope (%)	N/A	N/A	DWS Full Width?	N/A
N/A	Landing Curb? (Y/N)	N/A	N/A	DWS Offset (in)	N/A
N/A	Shared Landing?	N/A			
N/A	Gutter Ponding?	N/A	N/A	Gutter Slope (%)	N/A
N/A	Gutter Lip Ht (in)	N/A	N/A	Gutter X Slope (%)	N/A
N/A	Painted X Walk1?	No	N/A	Painted X Walk2?	No
	X Walk 1 Direction	To NW		X Walk 2 Direction	To SE
	X Walk 1 Width (in)	N/A		X Walk 2 Width (in)	N/A
	X Walk 1 Slope (%)	1.5		X Walk 2 Slope (%)	1.4
	X Walk 1 X Slope (%)	2.1		X Walk 2 X Slope (%)	1.3

N/A	Ramp inside XWalk1?	N/A	N/A	Ramp inside XWalk2?	N/A
	Road Slope (%)	1.2		Clear Space?	N/A
	Road X Slope (%)	0.8	N/A	Clear Space to XWalk (in)	N/A
N/A	Any Obstructions?	N/A	N/A	Storm Grate/Utility Hazard?	N/A
	Obstruction Type			Storm Grate/Utility Type	
		N/A			N/A
			Yes	Surface Condition? (G/P)	Good
			No	Curb Slope (%)	27.1

**Remove & Replace Curb Ramp With Two New Directional Ramps or Equivalent.**

Total Cost: \$ 3200.00
