# Access Compliance Report

## Public Rights-of-Way

### (Curb Ramps)

Intersection ID: N/A	Main Street: REA_RD	Cross Street: N/A	Location: NW
ADA ID: 0730D4F8C9E6	Ramp Type: Perp	Initial Pass/Fail: Pass	Overall Compliance: No
Codes/Mitigation Info/Possible Solution		Field Measurements/Component Compliance

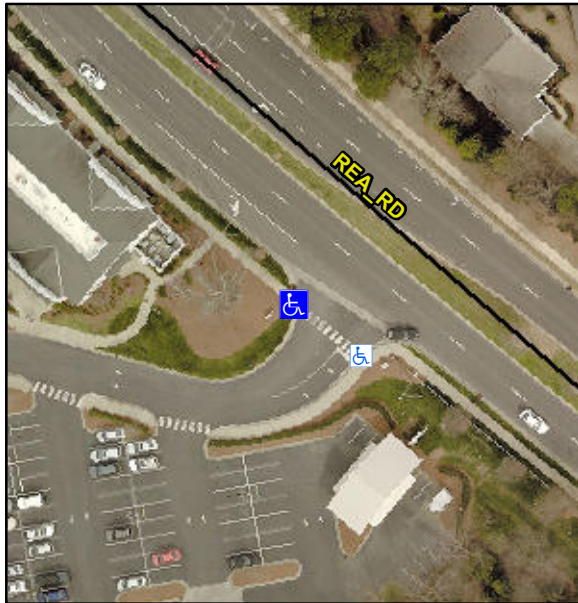
**Not Found, R304.2.1, R304.2.2-Perp, R304.3.2-Para, R304.5.3, R305.2**

Compliance	Description	Data	Compliance	Description	Data
N/A	Ramp Length (in)	75.0	Yes	Ramp Slope (%)	7.5
Yes	Ramp Width (in)	48.0	Yes	Ramp XSlope (%)	0.3
N/A	Flare Type LT	Sloped	N/A	Flare Type RT	N/A
N/A	Flare Slope LT (%)	5.9	Yes	Flare Slope RT (%)	4.4
N/A	Flare Traversable LT?	Yes	N/A	Flare Traversable RT?	Yes
No	Landing Length (in)	N/A	Yes	DWS Provided?	Yes
No	Landing Width (in)	N/A	Yes	DWS Contrast?	Yes
No	Landing Slope (%)	N/A	Yes	DWS Length (in)	24.0
No	Landing X Slope (%)	N/A	Yes	DWS Full Width?	Yes
N/A	Landing Curb? (Y/N)	No	No	DWS Offset (in)	4.0
N/A	Shared Landing?	No			
Yes	Gutter Ponding?	No	Yes	Gutter Slope (%)	2.0
Yes	Gutter Lip Ht (in)	0.0	Yes	Gutter X Slope (%)	0.2
N/A	Painted X Walk1?	Yes	N/A	Painted X Walk2?	N/A
	X Walk 1 Direction	To SE		X Walk 2 Direction	N/A
N/A	X Walk 1 Width (in)	60.0	N/A	X Walk 2 Width (in)	N/A
	X Walk 1 Slope (%)	1.0		X Walk 2 Slope (%)	N/A
	X Walk 1 X Slope (%)	1.8		X Walk 2 X Slope (%)	N/A

Yes	Ramp inside XWalk1?	Yes	N/A	Ramp inside XWalk2?	N/A
	Road Slope (%)	N/A	N/A	Clear Space?	Yes
	Road X Slope (%)	N/A	N/A	Clear Space to XWalk (in)	N/A
Yes	Any Obstructions?	No	Yes	Storm Grate/Utility Hazard?	No
	Obstruction Type			Storm Grate/Utility Type	
			N/A		N/A
			Yes	Surface Condition? (G/P)	Good

Possible Solutions:

**Remove & Replace Entire Ramp.**
