Access Compliance Report

Public Rights-of-Way

(Curb Ramps)

Intersection ID: 50600	Main Street: BENDING_BRANCH_RD	Cross Street: HEARTLEAF_RD	Location: SE
ADA ID: 0733CD9AFC4A	Ramp Type: Perp	Initial Pass/Fail: Fail	Overall Compliance: No
Severity Score: 22.5			
Codes/Mitigation Info/Possible Solution		Field Measurements/Component Compliance

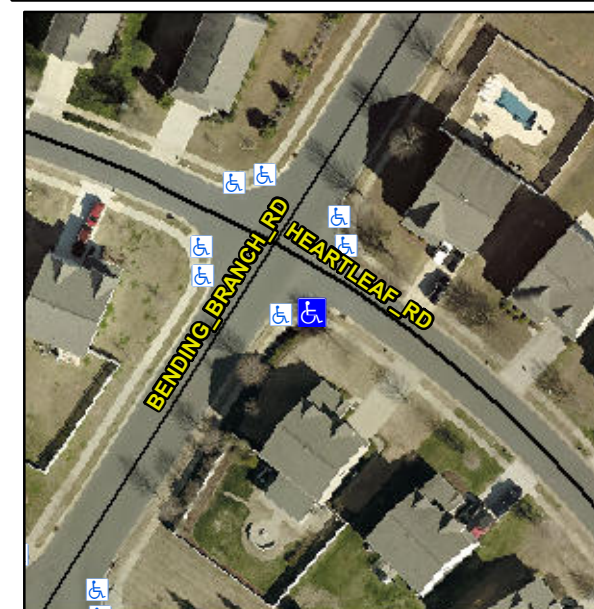
Not Found, R304.5.1, R304.2.2, R304.5.3

Compliance	Description	Data	Compliance	Description	Data
N/A	Ramp Length (in)	47.0	No	Ramp Slope (%)	9.9
No	Ramp Width (in)	47.5	No	Ramp XSlope (%)	5.0
N/A	Flare Type LT	N/A	N/A	Flare Type RT	N/A
N/A	Flare Slope LT (%)	N/A	N/A	Flare Slope RT (%)	N/A
N/A	Flare Traversable LT?	N/A	N/A	Flare Traversable RT?	N/A
N/A	Landing Length (in)	N/A	N/A	DWS Provided?	N/A
N/A	Landing Width (in)	N/A	N/A	DWS Contrast?	N/A
N/A	Landing Slope (%)	N/A	N/A	DWS Length (in)	N/A
N/A	Landing X Slope (%)	N/A	N/A	DWS Full Width?	N/A
N/A	Landing Curb? (Y/N)	N/A	N/A	DWS Offset (in)	N/A
N/A	Shared Landing?	N/A			
N/A	Gutter Ponding?	N/A	N/A	Gutter Slope (%)	N/A
N/A	Gutter Lip Ht (in)	N/A	N/A	Gutter X Slope (%)	N/A
N/A	Painted X Walk1?	No	N/A	Painted X Walk2?	N/A
	X Walk 1 Direction	To NE		X Walk 2 Direction	N/A
N/A	X Walk 1 Width (in)	N/A	N/A	X Walk 2 Width (in)	N/A
	X Walk 1 Slope (%)	1.9		X Walk 2 Slope (%)	N/A
	X Walk 1 X Slope (%)	3.9		X Walk 2 X Slope (%)	N/A

Remove & Replace Entire Ramp.

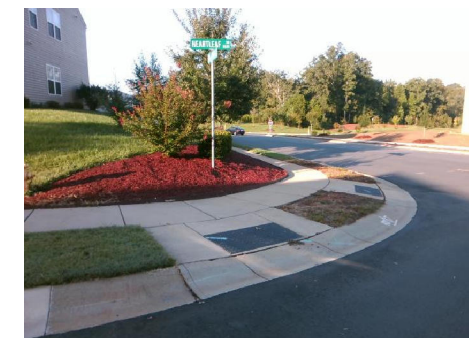
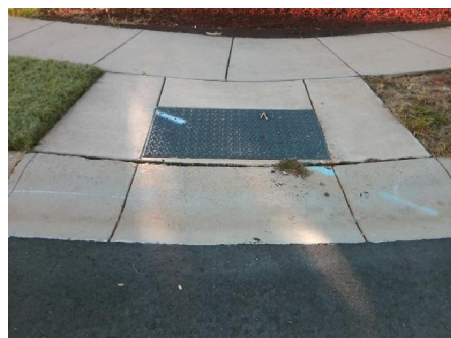
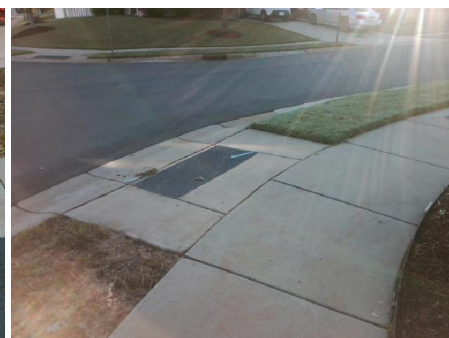
N/A	Ramp inside XWalk1?	N/A	N/A	Ramp inside XWalk2?	N/A
	Road Slope (%)	N/A	N/A	Clear Space?	N/A
	Road X Slope (%)	N/A	N/A	Clear Space to XWalk (in)	N/A
N/A	Any Obstructions?	N/A	N/A	Storm Grate/Utility Hazard?	N/A
	Obstruction Type			Storm Grate/Utility Type	
		N/A			N/A
			Yes	Surface Condition? (G/P)	Good
