Access Compliance Report Public Rights-of-Way (Curb Ramps)

Intersection ID: 49933 Main Street: MARVIN_RD Cross Street: WOBURN_RD Location: NE **Overall Compliance: No Severity Score:** ADA ID: 074A7A8D0A70 Ramp Type: Perp Initial Pass/Fail: Fail 12.5

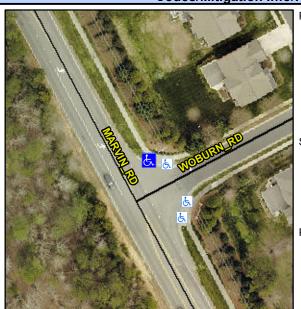
Field Measurements/Component Compliance								
Compl	iance Description	Data	Compl	iance	Description	Data		
N/A	Ramp Length (in)	59.0	Yes	Ramp	Slope (%)	7.3		
Yes	Ramp Width (in)	48.0	No	Ramp	XSlope (%)	5.1		
N/A	Flare Type LT	N/A	N/A	Flare	Type RT	N/A		
N/A	Flare Slope LT (%)	N/A	N/A	Flare	Slope RT (%)	N/A		
N/A	Flare Traversable LT?	N/A	N/A	Flare	Traversable RT?	N/A		
N/A	Landing Length (in)	N/A	N/A	DWS	Provided?	N/A		
N/A	Landing Width (in)	N/A	N/A	DWS	Contrast?	N/A		
N/A	Landing Slope (%)	N/A	N/A	DWS	Length (in)	N/A		
N/A	Landing X Slope (%)	N/A	N/A	DWS	Full Width?	N/A		
N/A	Landing Curb? (Y/N)	N/A	N/A	DWS	Offset (in)	N/A		
N/A	Shared Landing?	N/A						
N/A	Gutter Ponding?	N/A	N/A	Gutte	r Slope (%)	N/A		
N/A	Gutter Lip Ht (in)	N/A	N/A	Gutte	r X Slope (%)	N/A		
N/A	Painted X Walk1?	No	N/A	Paint	ed X Walk2?	N/A		
	X Walk 1 Direction	To W		X Wa	lk 2 Direction	N/A		
N/A	X Walk 1 Width (in)	N/A	N/A	X Wa	lk 2 Width (in)	N/A

X Walk 1 Slope (%)	2.7		X Wa	lk 2 Slope (%)	N/A		
	X Walk 1 X Slope (%)	5.6		X Wa	lk 2 X Slope (%)	N/A		
N/A	Ramp inside XWalk1?	N/A	N/A	Ramp	inside XWalk2?	N/A		
	Road Slope (%)	5.6	N/A	Clear	Space?	N/A		
	Road X Slope (%)	2.7	N/A	Clear	Space to XWalk (in)	N/A		
N/A	Any Obstructions?	N/A	N/A	Storm	n Grate/Utility Hazard?	N/A		
	Obstruction Type			Storm	n Grate/Utility Type			
		N/A				N/A		
			Yes	Surfa	ce Condition? (G/P)	Good

MARVIN RD Street 1 Name Stop Condition-Street 2 None Street 2 Name N/A Stop Condition-Street 1 N/A Possible Solutions: Remove & Replace Entire Ramp. Surveyor Notes: N/A PROW/ADA: Not Found, R304.5.3

Total Cost:	\$ 1850.00
